Climate Change, Conflict, And Heritage Preservation in Al-Qahira Citadel.

AHRC IAA_Climate change, conflict, and heritage preservation in Al-Qahira Citadel

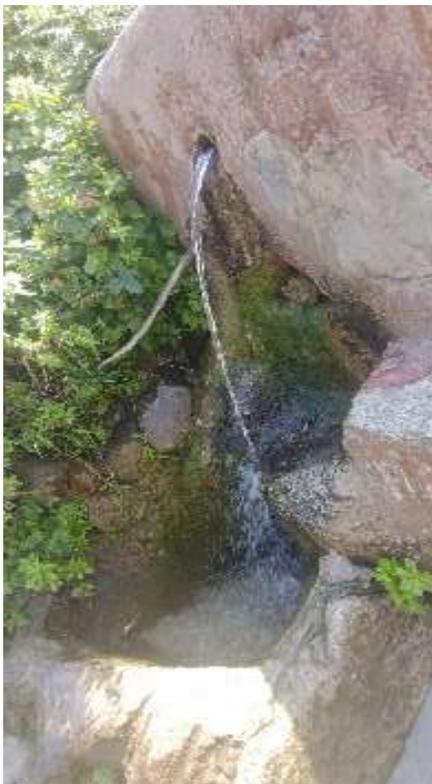
Figure (1):The image shows the water spring in Mount Sabir.

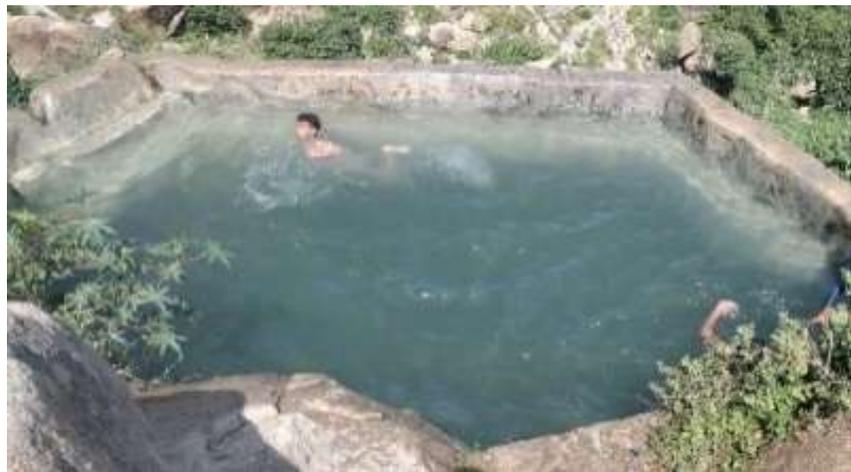
Figure (2): The image shows the collection basin in Mount Sabir near the water spring, connected to it by an open water channel.

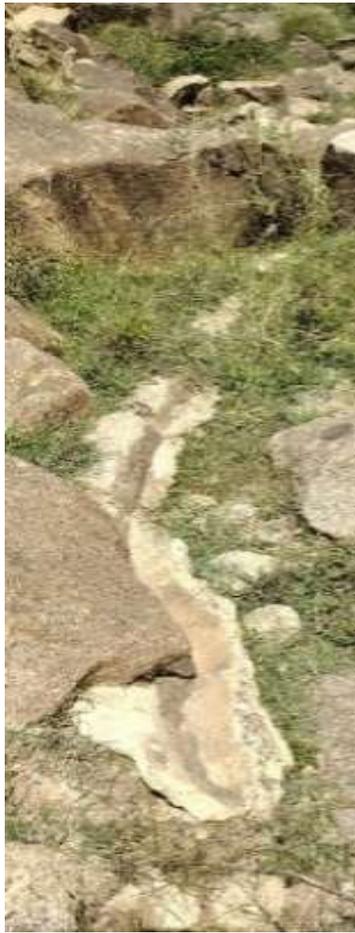
Figure (3):The images show remains of water channels in Mount Sabir.

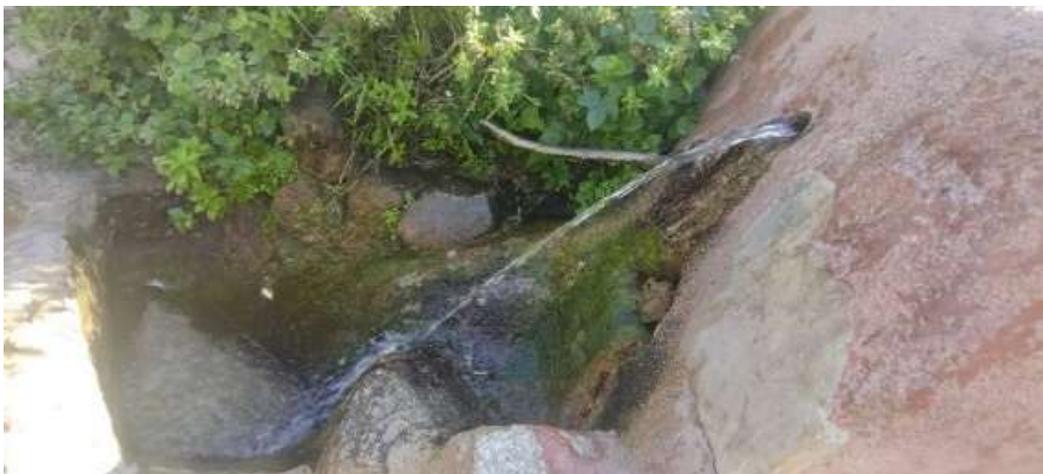
Water Source (The Water Spring): The primary supply source, located at a high elevation on the slope of Mount Sabir, surrounded by a stone structure to protect it from mountainous terrain hazards and rockslides, as shown in Figure (6).

Figure (6):The image shows the water spring in Mount Sabir.

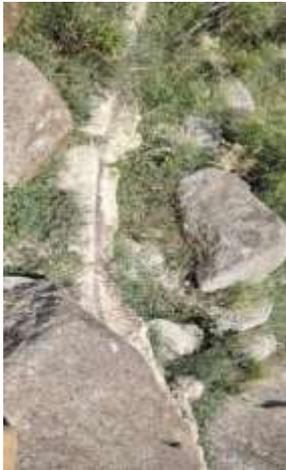
The Open Water Channel: It is directly connected to the water spring and functions to convey water from the spring to the collection basin; it is constructed with slight slopes to prevent stagnation or loss and features raised

edges that protect the water from leaking outside the channel. It was built using local stones and coated with Qudad to protect it from mechanical impacts caused by rocks and stones, and to mitigate deterioration factors and climatic effects, as shown in Figure (7).

Figure (7) :The image shows the remains of water channels in Mount Sabir according to the architectural vestiges, and on the right shows plan of the open water channels.

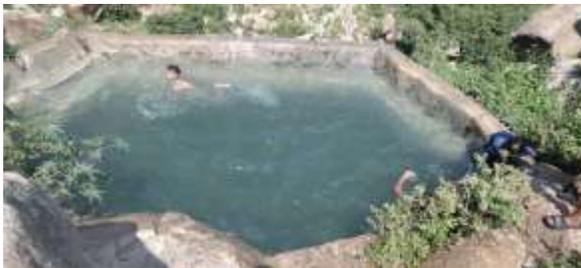
The Collection Basin (Intermediate Tank): A pivotal element in the system, constructed from local stones and coated with Qudad on both the interior and exterior to withstand water pressure; it is located at an elevation lower than the water spring and higher than Al-Qahira Citadel, functioning to regulate flow, allow for the sedimentation of impurities, and generate a hydraulic head difference, as shown in Figure (8).

Figure (8) : The image shows the collection basin and the water channels branching from it; the plan on the right clarifies the collection basin and its diverging water channels.

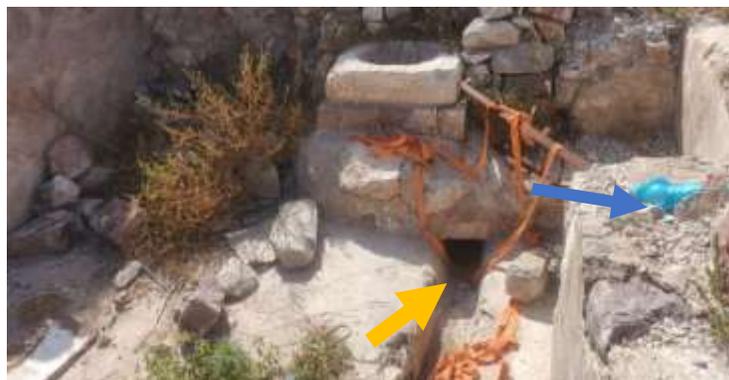
Drinking Water Tank: There are two drinking water reservoirs in the citadel carved into the rock and covered from above; they receive a portion of the water flowing from the collection basin, as shown in Figure (10).

Figure (10): The image shows the drinking water reservoir; the yellow arrow represents the water inlet from the channels for filling the reservoir, while the blue arrow represents the overflow outlet from the reservoir via buried channels.

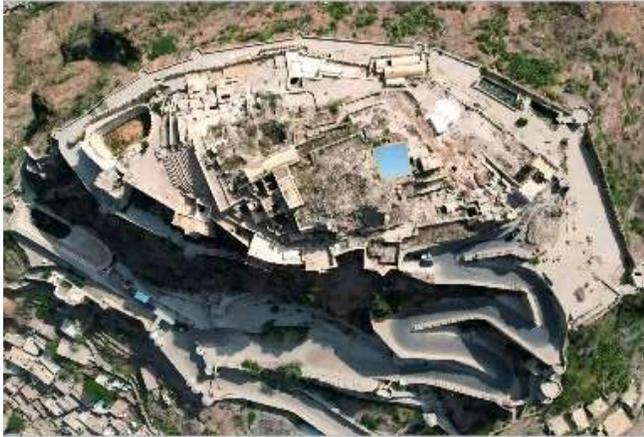
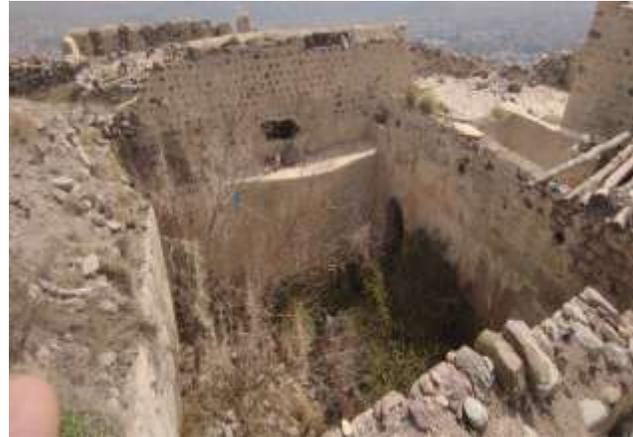
The Palace Pool: Located at the highest peak within the citadel, adjacent to the Emirate Palace, this pool was carved into the rock. According to field surveys and measurements by the General Authority for Antiquities and Museums, Taiz branch, the length of this pool is approximately 10 meters and its width is 10 meters, while its depth reaches 5.5 meters, with a storage capacity estimated at about 550,000 liters of water. It is constructed from

stone and lined with a layer of Qudad, as shown in Figure (11).

Figure (11) on the right the image shows the Palace Pool in the citadel, 2025; an aerial photograph of the citadel shows the location of the Palace Pool.

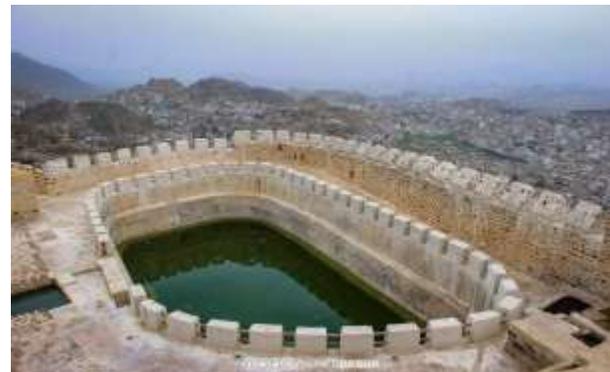
The Fortress Pool: located in the northwestern part of the citadel's fortress, measuring 22.7 meters in length and 11.6 meters in width with a depth of 7 meters. It accommodates approximately 1,843,240 liters, is carved into the rock, and built from stones and baked bricks Yagur stone with Qudad, as shown in Figure (12).

Figure (12): On the right, the image shows the location of the Fortress Pool within the citadel, highlighted in blue; on the left, a close-up image of the Fortress Pool, 2011.

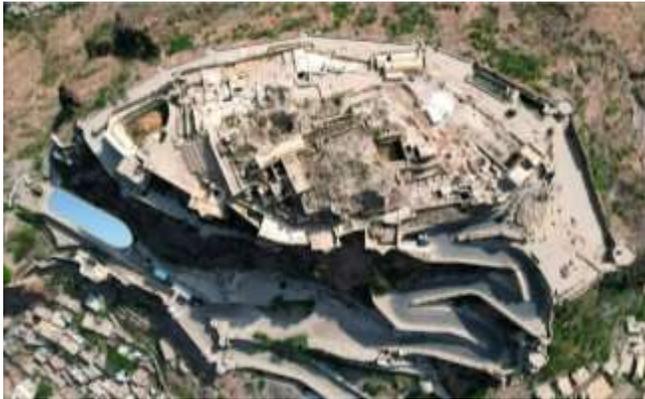
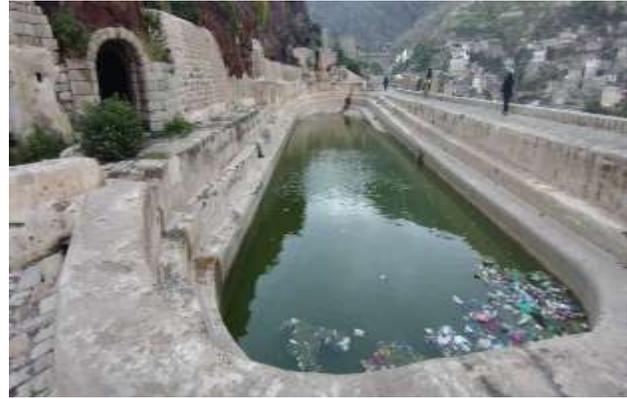
The Western Pool: Located in the lower part of Al-Qahira Citadel, specifically on the western side; its length is 41.3 meters, its width is 9.5 meters, and its average depth is 2.5 meters. It accommodates approximately 980,875 liters and is built of stone coated with Qudad, as shown in Figure (13).

Figure No. (13): The image shows the location of the Western Pool within the citadel highlighted in blue; a close-up image of the Western Pool, 2025.

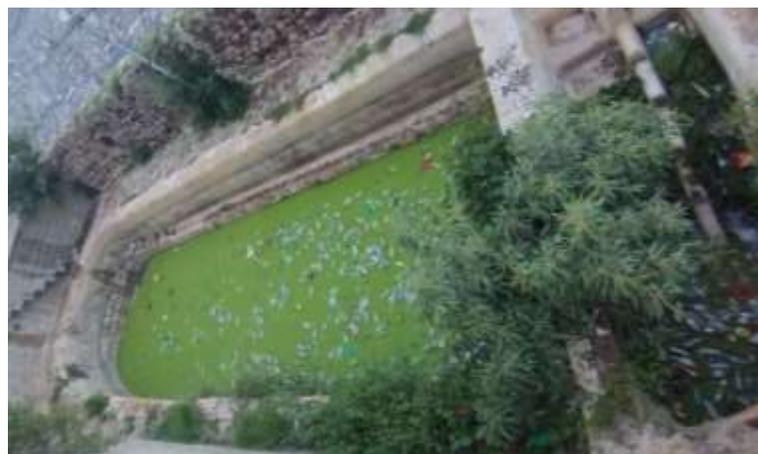
The Eastern Pool of the Citadel: It is located to the east of the citadel, measuring 14.6 meters in length and 5.3 meters in width, with a depth of 5.3 meters. It accommodates approximately 518,446 liters and is built of stone coated with Qudad, as shown in Figure (14).

Figure No. (14): The image shows the location of the Eastern Pool within the citadel highlighted in blue; a close-up image of the Eastern Pool, 2025.

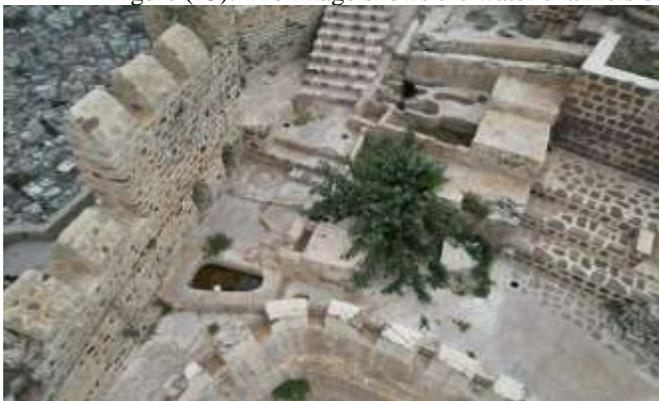
Figure (16): The image shows the water filters before reaching the pool, 2025.

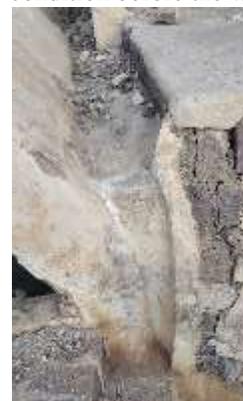
Figure (17): The image shows the thickness of the Qudad used in coating the water channels of the citadel, 2025.

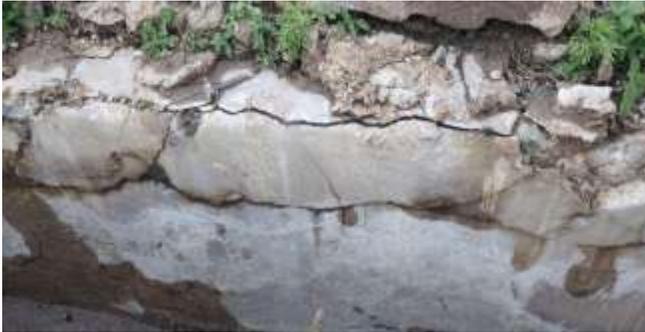
Figure (18): The image shows the deterioration of Qudad material from the water channel due to climate change (drought), 2025

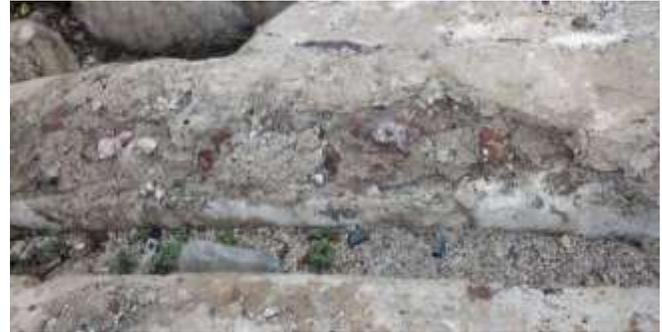
Figure (19): The image shows the deterioration of Qudad material from the water channel due to war, revealing the stones and baked bricks (yajour) used in construction, 2025.

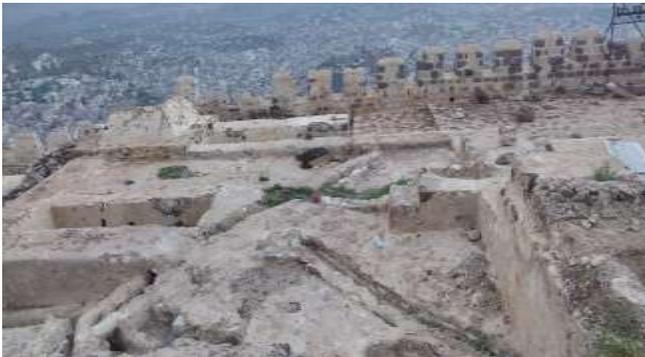
Figure (21): The image shows the deterioration of Qudad material from the water channel due to climate change (drought), 2025.

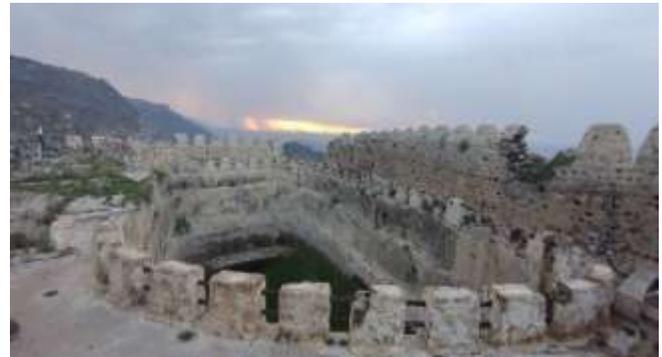
Figure (22): The image shows the deterioration of Qudad material and the collapse of parts of the pool wall due to climate change (drought) and conflicts, 2025.

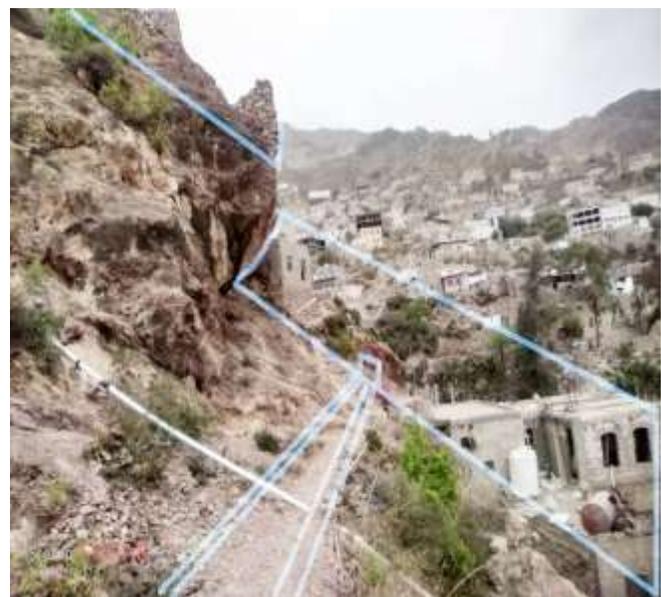
In addition to supplying the citadel with its water needs, field evidence and local accounts indicate the existence of a complementary technique for conveying surplus water from the citadel's cisterns to the Old City; this water was drained through open channels extending from the citadel toward the residential clusters below, benefiting from the natural elevation differences. According to residents' testimonies, this system contributed to meeting the population's water needs, particularly during periods of scarcity, reflecting the citadel's role not only as a defensive facility but as a vital center for managing water resources and serving the surrounding urban fabric, as shown in Figure (24).

Figure (25): The drawing on the right how the citadel and the city were supplied with water via water channels (Source: The Book of Ain al-Dam'a: The Old City by Jamil al-Abyadh); the image on the left illustrates the current situation, 2025.

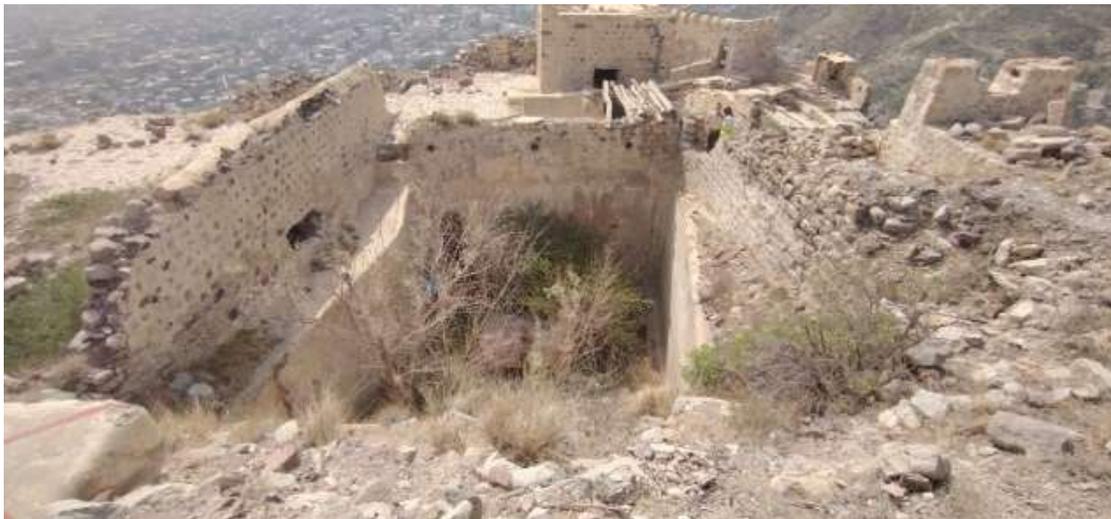
Granite stone is the primary material used in constructing pools, cisterns, open channels, and the load-bearing walls of water facilities. Local mountain granite extracted from the vicinity of the citadel and Mount Sabir was utilized, characterized by its relative hardness and ability to withstand loads and water pressure. The stone was laid in a deliberate manner in relatively regular courses within pools and cisterns, with attention given to minimizing internal gaps to reduce water permeability.

Figure (25): The image shows the natural stone material used in the construction of the Palace Pool.

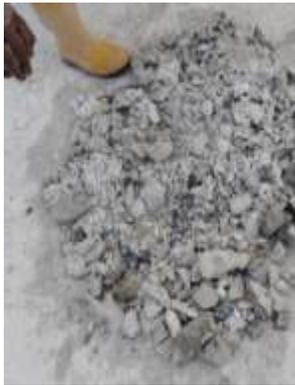
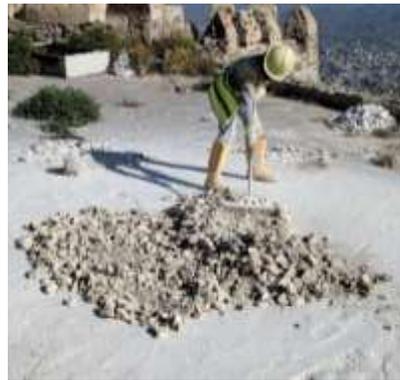
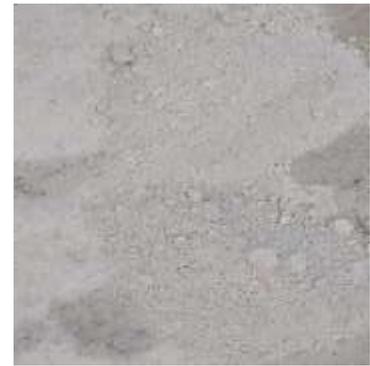
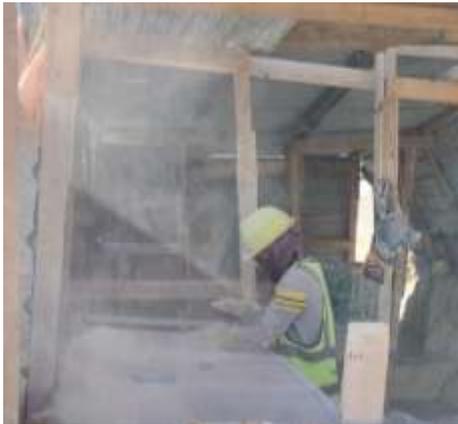
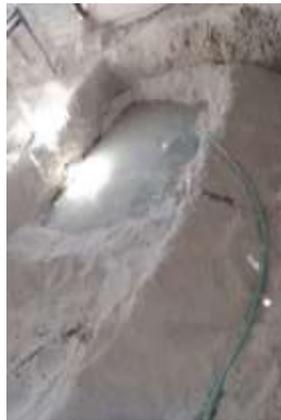
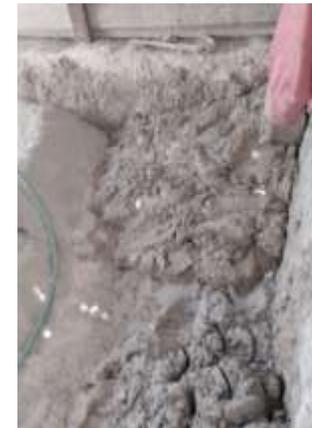
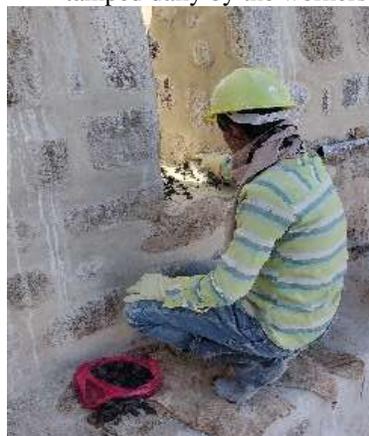
Traditional Qudad is prepared through several precise steps that ensure it attains the hardness and durability required for architectural works, particularly in historical buildings and water systems. The process begins with calcining limestone at temperatures reaching 1000°C to produce quicklime, which is then slaked with water to become usable lime (noura). Subsequently, the resulting lime is mixed with volcanic stone (gravel) in a specific ratio of 3:2 to obtain a cohesive mixture.

The mixture is then left to ferment for several weeks until it is ready for use and acquires the necessary strength and flexibility. During application, Qudad is placed on surfaces with a thickness ranging between 6 and 7 centimeters; the surface is then smoothed using a smooth stone to achieve a uniform finish and is subsequently coated with animal fat to saturate the material and increase its resistance to weather elements and water, as shown in Figure (26).

(1) begins by sprinkling a little water on the Qudad and leaving it to react with the water for some time.

(2) Then, the worker turns over the Qudad and breaks down any parts that did not disintegrate during the water reaction.

(3) Qudad material after the slaking process.

(4) After completing the slaking process, the lime (nora) is sieved and cleaned of damaged and unusable stones

(5) Then, the lime (nora) undergoes a fermentation process with water for 2 to 4 weeks, during which the mixture is tamped daily by the workers' feet

(6) The **Qudad** material in its final form is now ready for use

(7) The image shows the process of applying the Qudad tamping/burnishing material to fill cracks and smooth the surface
Figure (26): the seven processes of preparing Qudad material

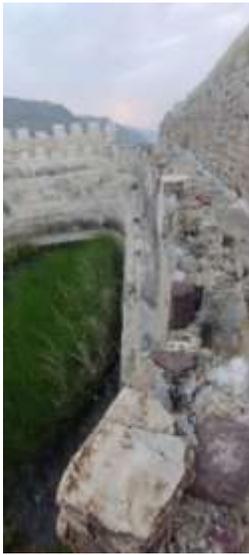
Pools and cisterns suffer from several problems that have affected their efficiency and function over time, as structural cracks, as shown in Figure (27) of varying widths have appeared in the walls and floors, contributing to the weakening of their general structure. It was also noted that parts of the qudad layer have been lost or have degraded in several places as shown in Figure (28), leading to water leakage, especially during rainfall. Additionally, stones and binding mortar have undergone erosion as shown in Figure (29), particularly in areas most exposed to continuous moisture. The accumulation of sediment and dust inside some pools has also increased the pressure on the floors, exacerbating signs of damage and negatively affecting their structural integrity

Figure (27): The image shows cracks and voids in the cistern walls.

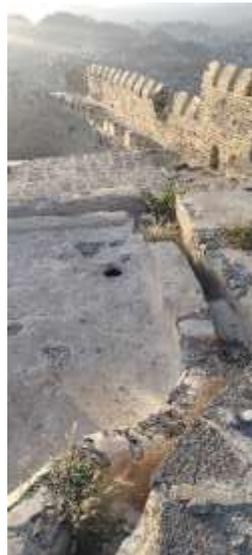
Figure (28): The image shows the deterioration of the qudad material

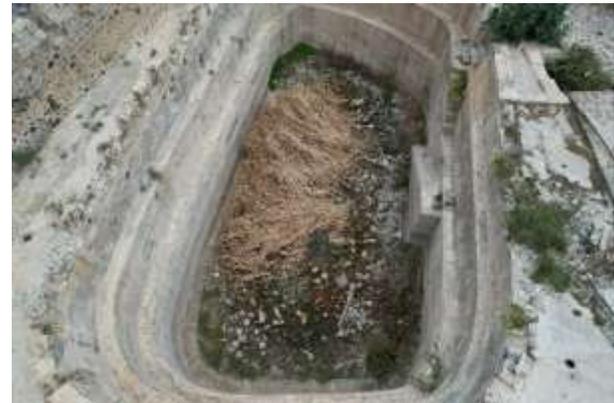
Figure (29): The image shows the accumulation of dust and sediment in the pools

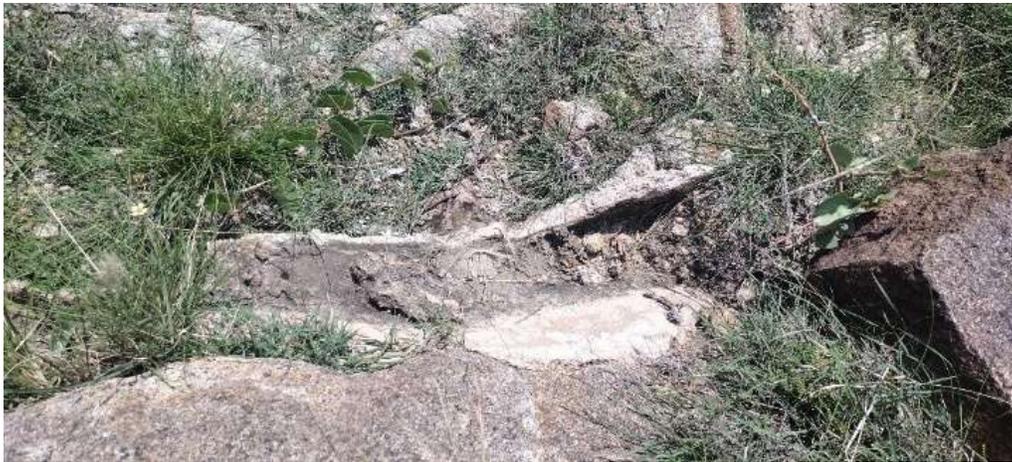
The channels and conduits have suffered significant damage that led to the decline of their functional role, with extensive parts of them having disappeared as shown in Figure (31), particularly in areas located outside the citadel's perimeter, as shown in Figure (7). The remaining channels suffer from clear blockages due to the accumulation of dust and rock collapses, which hindered the movement of water within them. This has resulted in the loss of functional connectivity between the collection, storage, and drainage elements, thereby disrupting the water system in general. Regarding general stability, some water elements were affected by the instability of the rocky slopes upon which the citadel stands, which reflected negatively on their structural integrity. Indicators of

localized weakness in the foundations have also appeared as a result of water leakage and the absence of periodic maintenance, which increases the likelihood of worsening damage in the future.

Figure (31): Remains of a conduit destroyed by rock collapses.

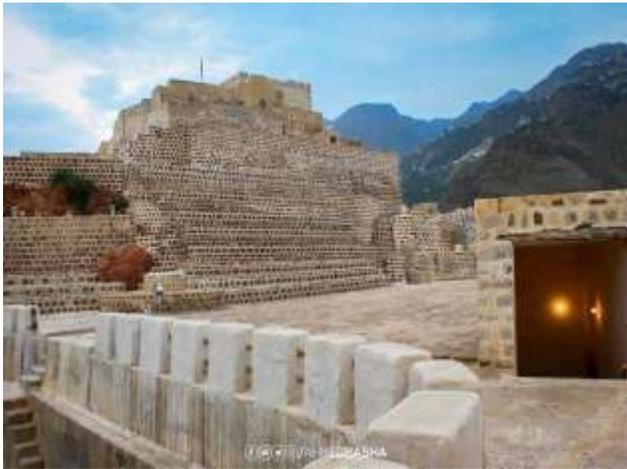
At the end of the 1990s, specifically since 1998 AD, the General Authority for Antiquities— in cooperation with local authorities—began the first restoration works in the citadel, which started with organized archaeological excavations. Actual restoration works for the citadel began within a project aimed at reviving this important historical landmark, and the initial works included extensive excavation operations to remove soil accumulations and reveal buried architectural elements. During this stage, foundations of buildings and internal palaces were discovered, and the features of the towers became clear, as shown in Figure (2).

Figure (2): Shows the internal restoration works near the northern tower of Al-Qahira Citadel, 2012, Source: General Authority for Antiquities and Museums, Taiz Branch

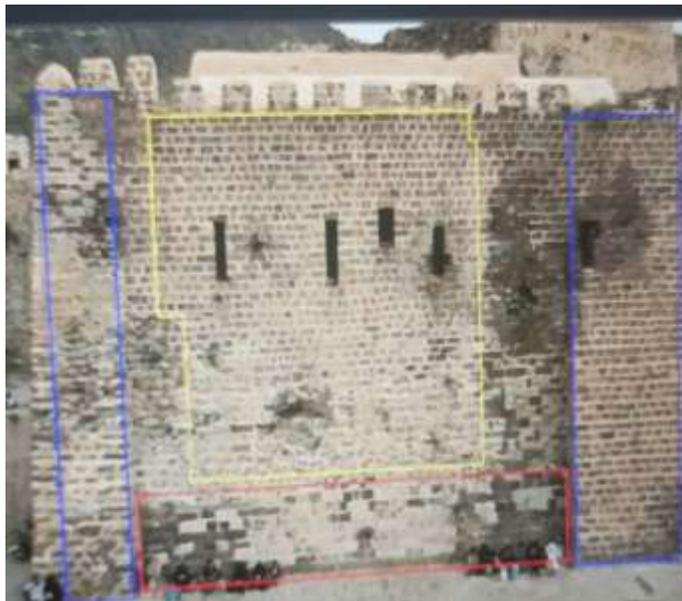
From the mentioned historical sequence of the northeastern tower, it is evident that the tower's construction structure consists of different historical layers: the sultans' rule period, the Ottoman rule period, and the Republican era, which will be documented during the tower documentation works, as shown in Figure (3).

■ the Sultans Period
■ the Ottoman Period
■ Republican period

Figure (3) shows the stages of development of the northern tower construction, Source: General Authority for Antiquities and Museums, Taiz Branch

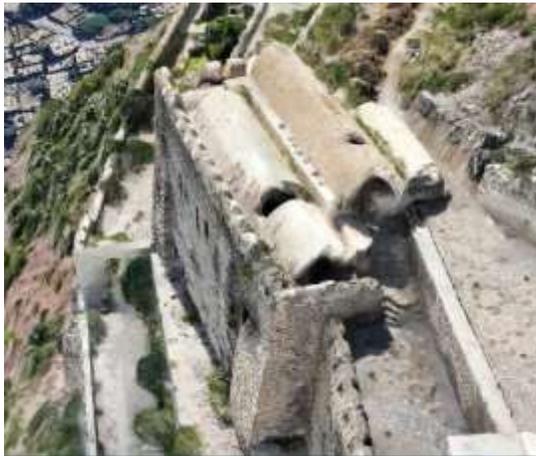
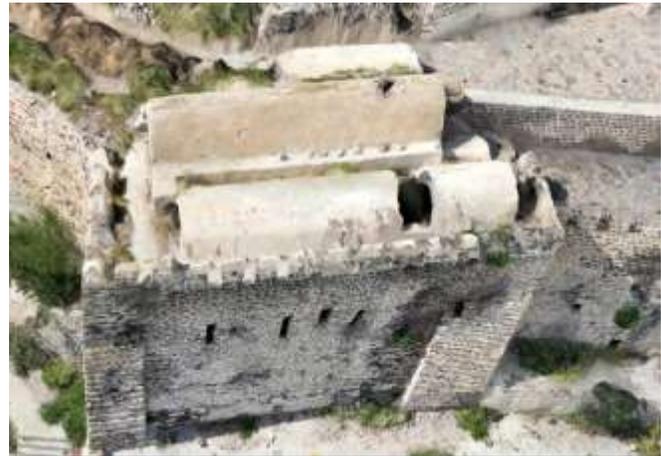
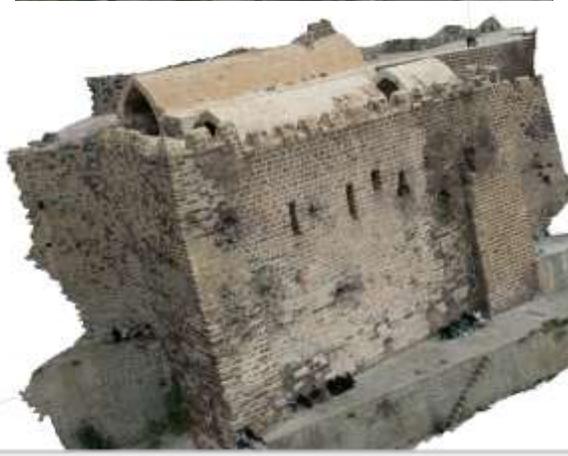
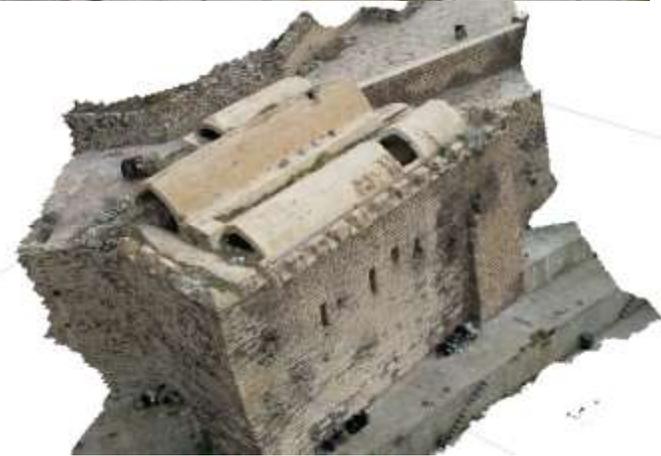
Figure (4) shows the three-dimensional model of the northern tower using Agisoft Metashape software.

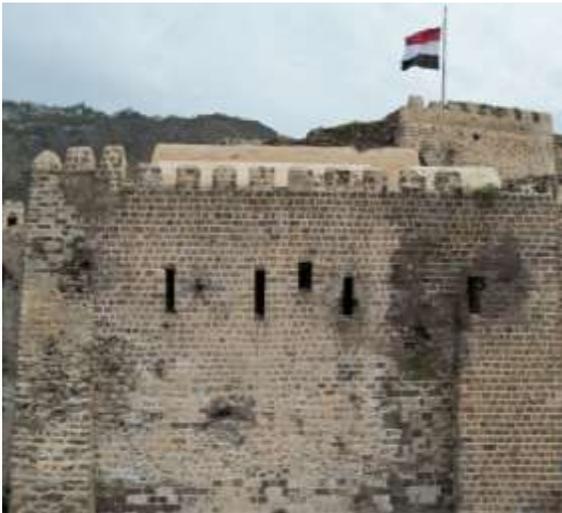
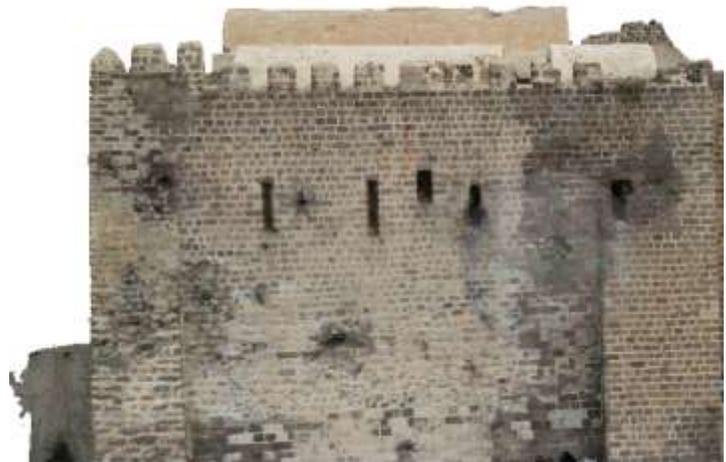
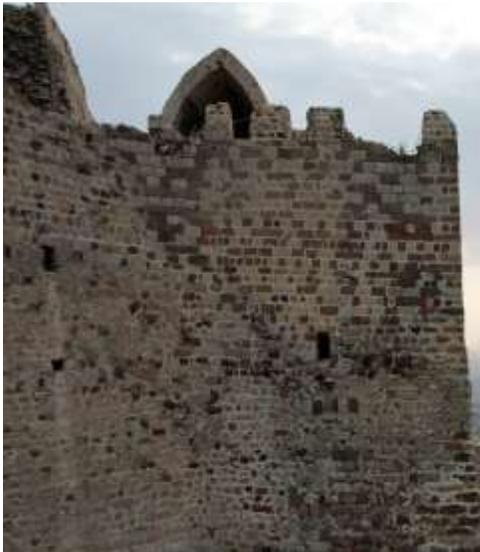
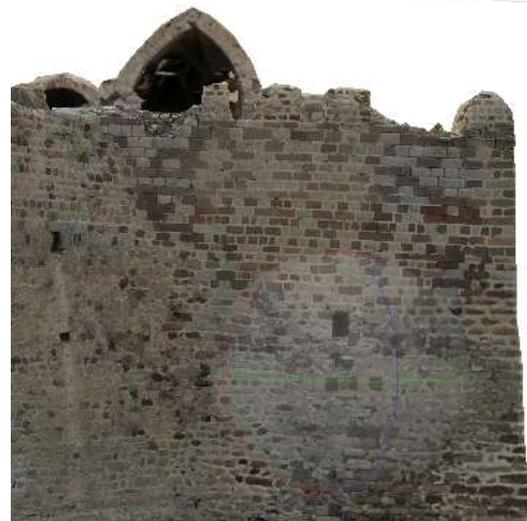
The following images show a direct comparison between the original images captured by the drone and the resulting three-dimensional model from processing them using Agisoft Metashape software, where the high match in engineering details and the surface texture of the stones is evident, confirming the program's efficiency in producing accurate digital models that represent the architectural reality of the building with high precision, as shown in Figure (5).

(a) Original image from the drone, Northern Façade of the Tower

(b) Image extracted from the Agisoft Metashape 3D model, Northern Façade of the Tower

Figure (5): Comparison between the original image taken by the drone and the resulting 3D model using Agisoft Metashape software.

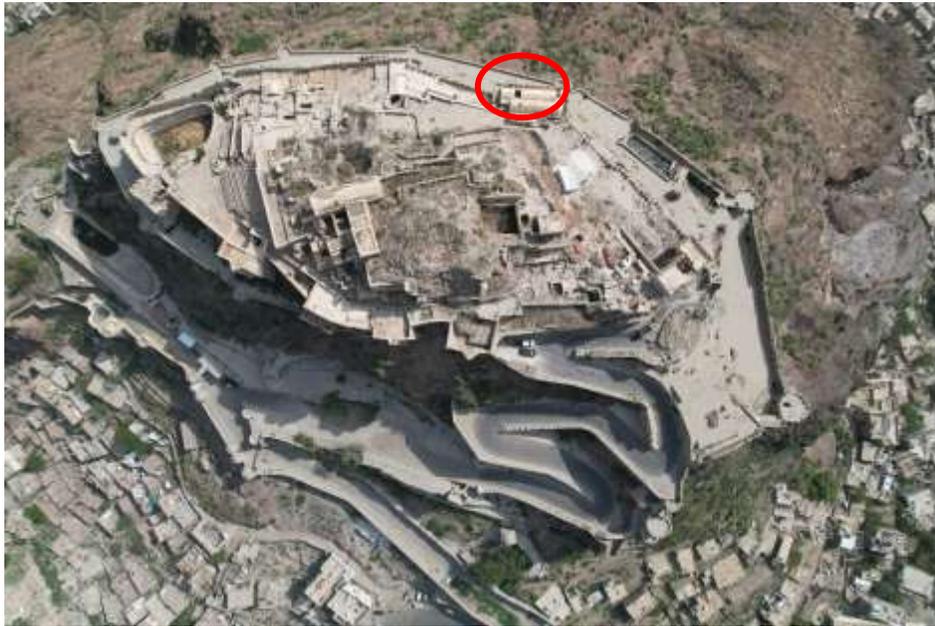
Figure (6) An aerial photo of the general site of Al-Qahira Citadel, showing the study area of the northern tower circled in red.

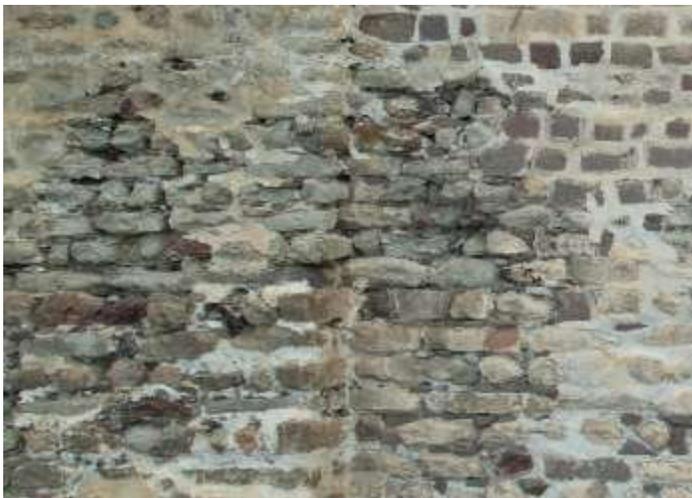
Figure (8): Erosion and crumbling of stones and erosion of the binding mortar on the northern facade of the tower.

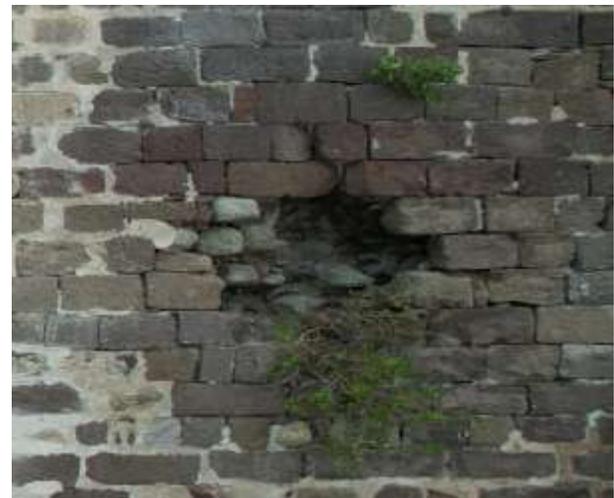
Figure (9): Growth of a shrub from the Mastic family on the northern facade of the tower without direct impact on structural stability.

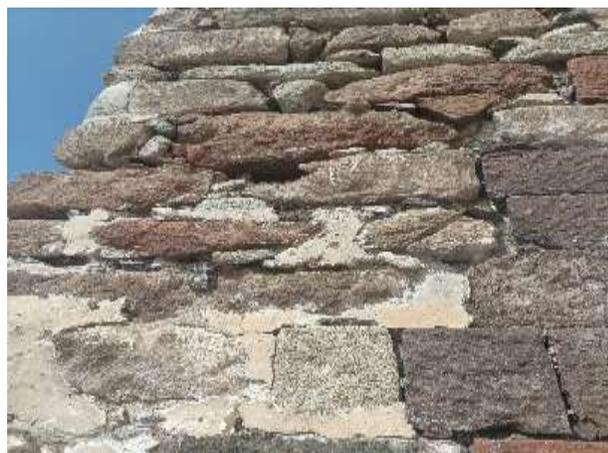
Figure (11): shows stone erosion

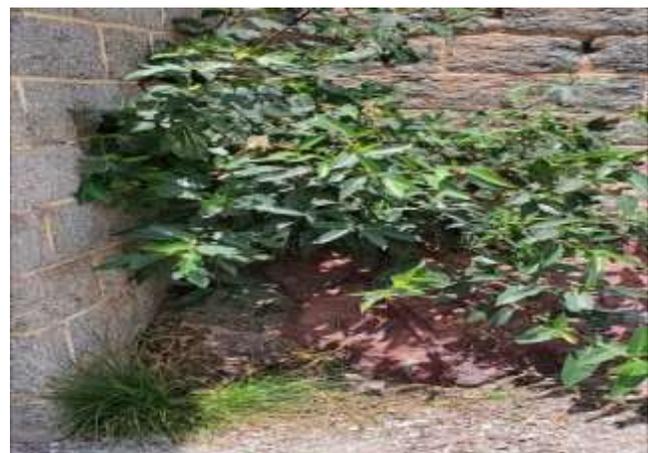
Figure (12): shows the biological and climatic factors affecting the tower

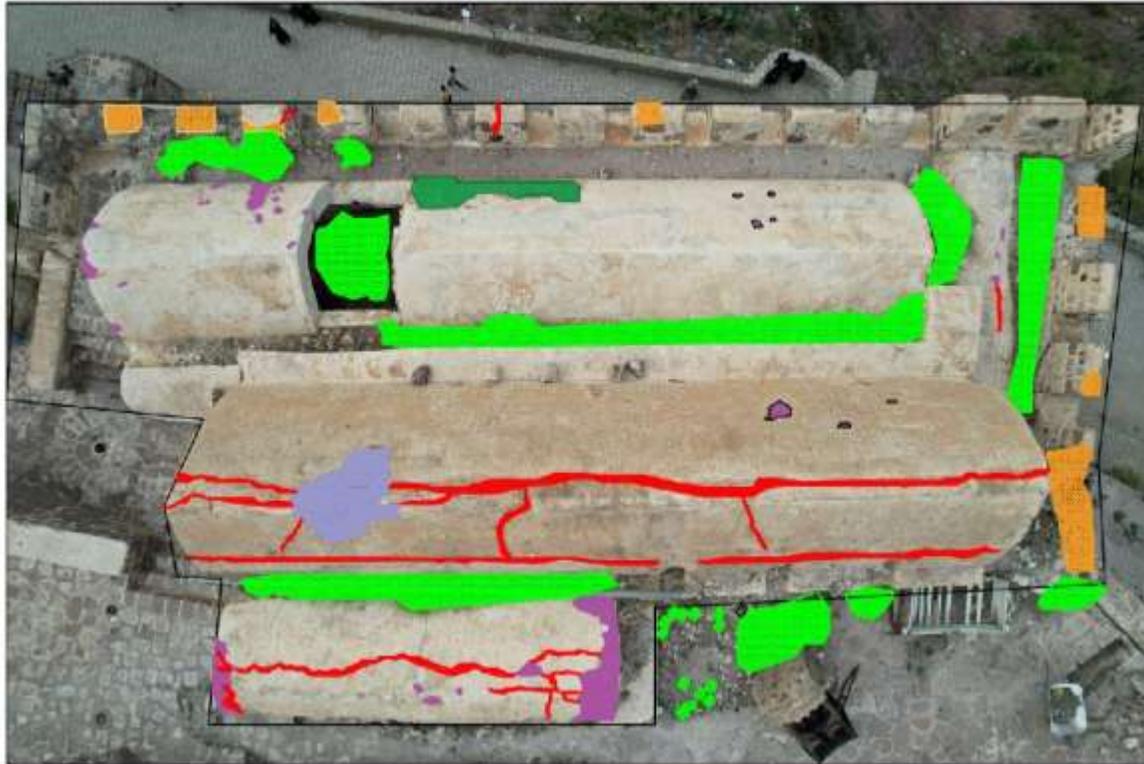
- ▬ Gaps in the walls
- ▬ Shattered stones
- ▬ Cracks
- ▬ Loos in the walls
- ▬ Humidity
- ▬ Vegetation
- ▬ Gaps in the roof
- ▬ Flaking in the roof

Figure (13): shows the damages on the barrel vaults of the Northern Tower.

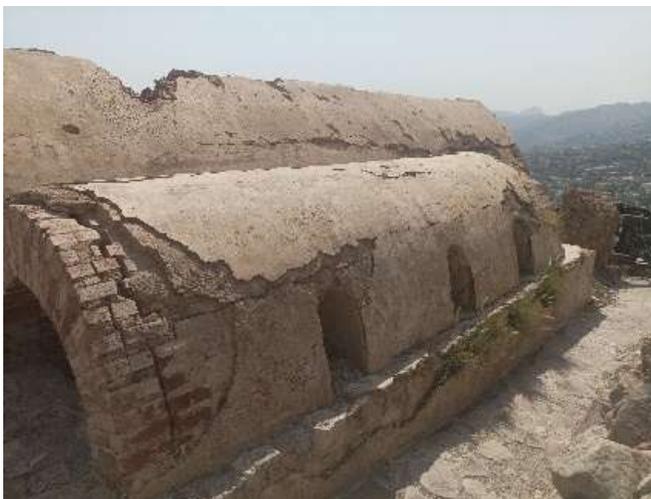
Figure (14): shows the presence of cracks

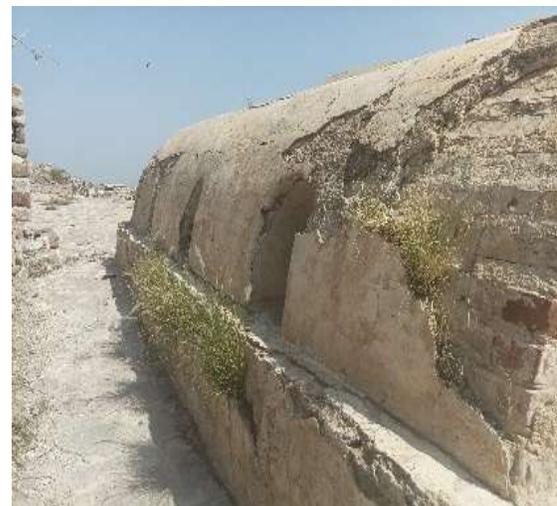
Figure (15): shows the plant *Cenchrus setaceus*

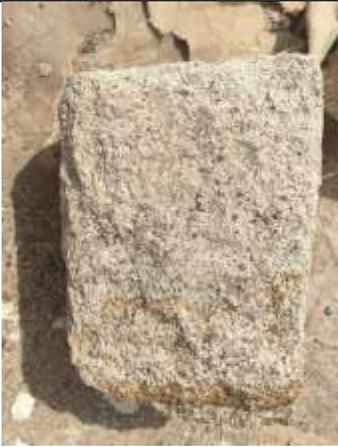
Granite	Igneous rock	It is characterized by its high hardness, durability, and resistance to erosion and weather factors. It absorbs less water, making it resistant to moisture and able to withstand thermal and humidity changes.

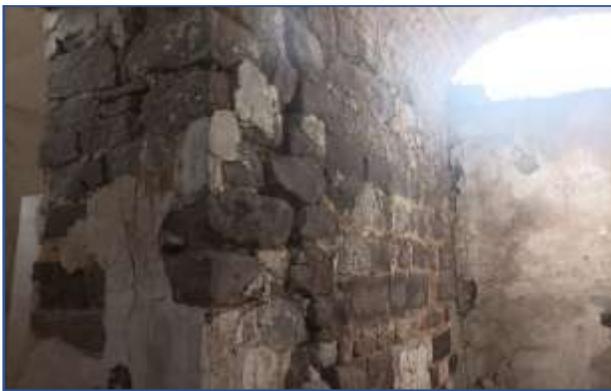
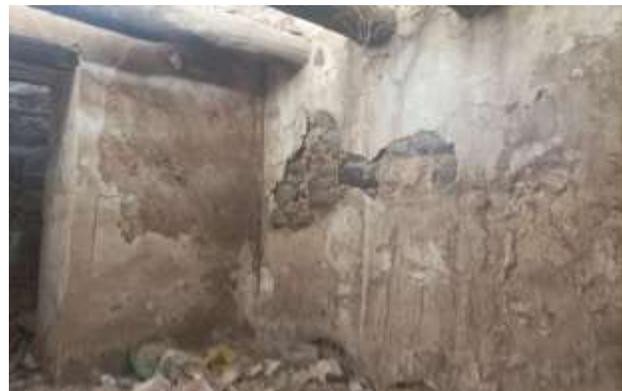
Upon water evaporation, salts crystallize inside the plaster pores and expand (salt crystallization), generating high internal pressures exceeding the adhesion strength between the plaster and stone surface. Peeling and separation of the plaster layer, mortar erosion, and exposure of the base stone surface.

Figure (16): shows the separation of the mortar layer from the stone surface.

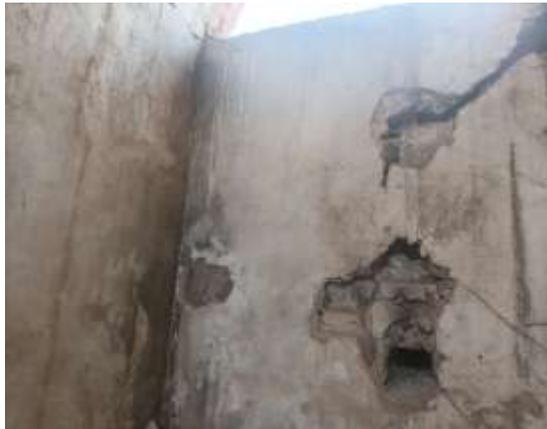
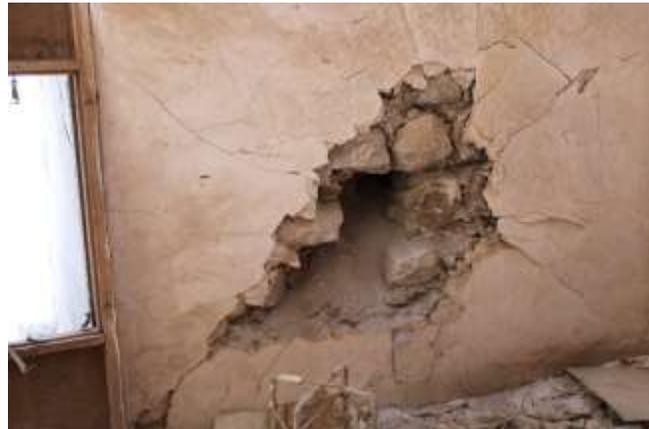
C. Cracks and Gaps Resulting from Conflict (Vibrations and Shells): The walls show cracks of multiple types, ranging from small transverse cracks to deep gaps penetrating the wall thickness, as shown in Figure (17). These gaps increase the wall's permeability and facilitate water and air penetration, easing salt transport and multiplying chemical and mechanical deterioration processes. The degree of damage ranges from transverse cracks to structural deteriorations requiring reinforcement interventions, support, and localized restoration at deep gaps.

Figure (17): shows the cracks and gaps in the internal walls.

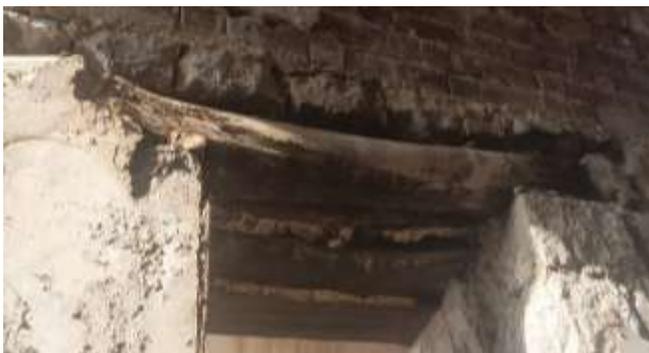
D. Damage to Wooden Lintels Above Openings (Doors and Windows): As a result of moisture penetration, wood deteriorates biologically (rotting) and due to insect activity, reducing the lintel's capacity to bear vertical loads of the stone blocks above it, leading to subsidence and secondary cracks in the walls above the lintel. These damages on the wooden lintels manifest as rotting and erosion due to the spread of termites (white ants), as shown in Figure (18). This requires assessing each lintel's condition: localized repair, partial reinforcement, or complete replacement if load-bearing capacity is lost.

Figure (18): shows the Damage to Wooden Lintels Above Openings (Doors and Windows).

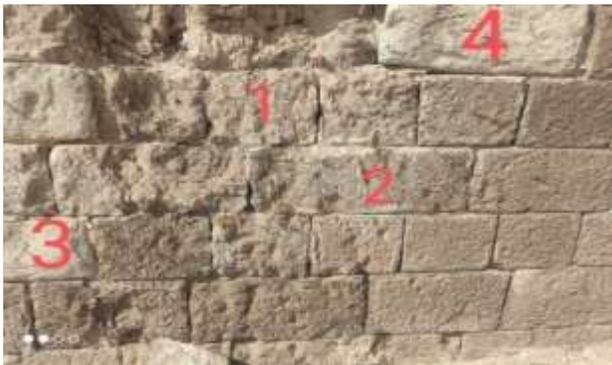
No.	Type of Stone	Moisture Level
1	Limestone	49
2	Limestone	30.4
3	Granite	24.1
4	Granite	18.9

Figure (23): the Protimeter moisture meter of the northern facade

The examination revealed that granite stones are not significantly affected by moisture, while limestone stones are more susceptible to its effect, especially in the lower parts near the foundations. It was observed that stones adjacent to the foundations are more humid than the rest of the stones. The results also showed that the northern and western façades are the most exposed to moisture compared to the rest of the façades, and this is likely due to their direct exposure to atmospheric factors.

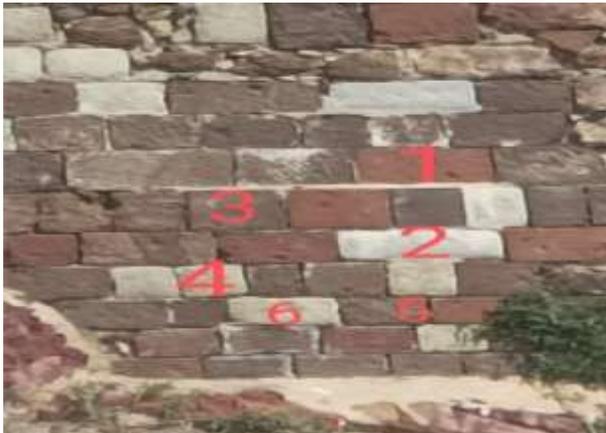
No.	Type of Stone	Moisture Level
1	Limestone	21.2
2	Granite	24.6
3	Limestone	19.8
4	Granite	12.4
5	Limestone	24.3
6	Granite	21.3

Figure (24): the Protimeter moisture meter of the western facade

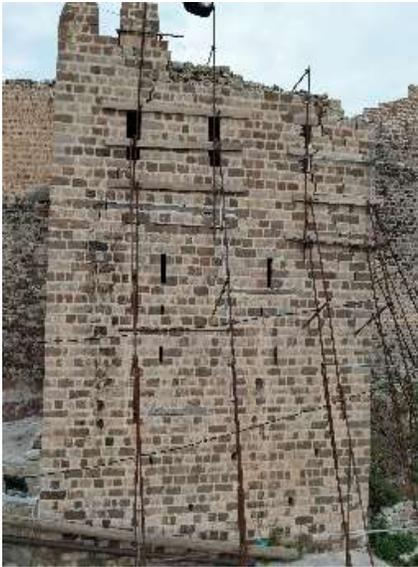
The first phase involved conducting a field visit to the Western Tower to perform a comprehensive visual survey of its structural condition; the tower was documented from inside and outside, and the three facades (western, northern, and southern) were inspected and documented. The inspection revealed that the wall thickness is approximately 0.90 m, reflecting the defensive character of the tower. Field measurements showed that the western facade height is about 12 m with a width of approximately 8.20 m, while the northern facade height is about 10.30

Figure 2: Shows the western facade (2025)

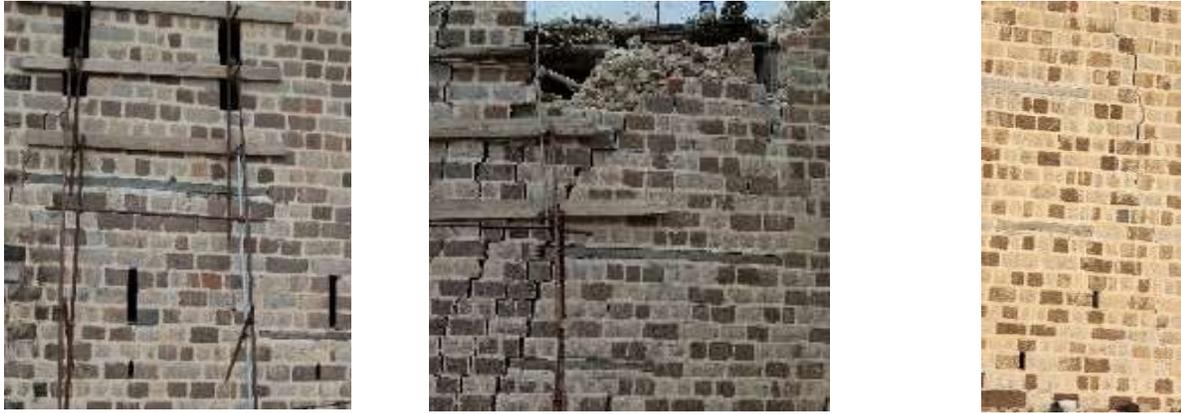
The results of the field analysis questionnaire for the structural condition of the Western Tower showed an absence of surface hardening manifestations in the stone materials, as shown in Figure 5, where this indicator recorded a value of (0), indicating direct exposure of the structural and natural elements to environmental factors without the presence of surface protection layers.

Figure 5 also shows a close-up image illustrating that the results indicate the presence of stone cracks, as the Western Tower recorded a medium level of cracking with a value of (3), which is likely related to structural loads and the effect of accumulated moisture in the stone masses. The questionnaire results showed an absence of stratification levels in the stone used in the tower (0), indicating no clear separation along geological bedding planes. In contrast, no manifestations of scaling were observed in the tower stone (0).

Figure 5: The images show the tower facades in high resolution, illustrating the condition of the stones, 2025.
