Climate Change, Conflict, And Heritage Preservation in Al-Qahira Citadel.

AHRC IAA_Climate change, conflict, and heritage preservation in Al-Qahira Citadel

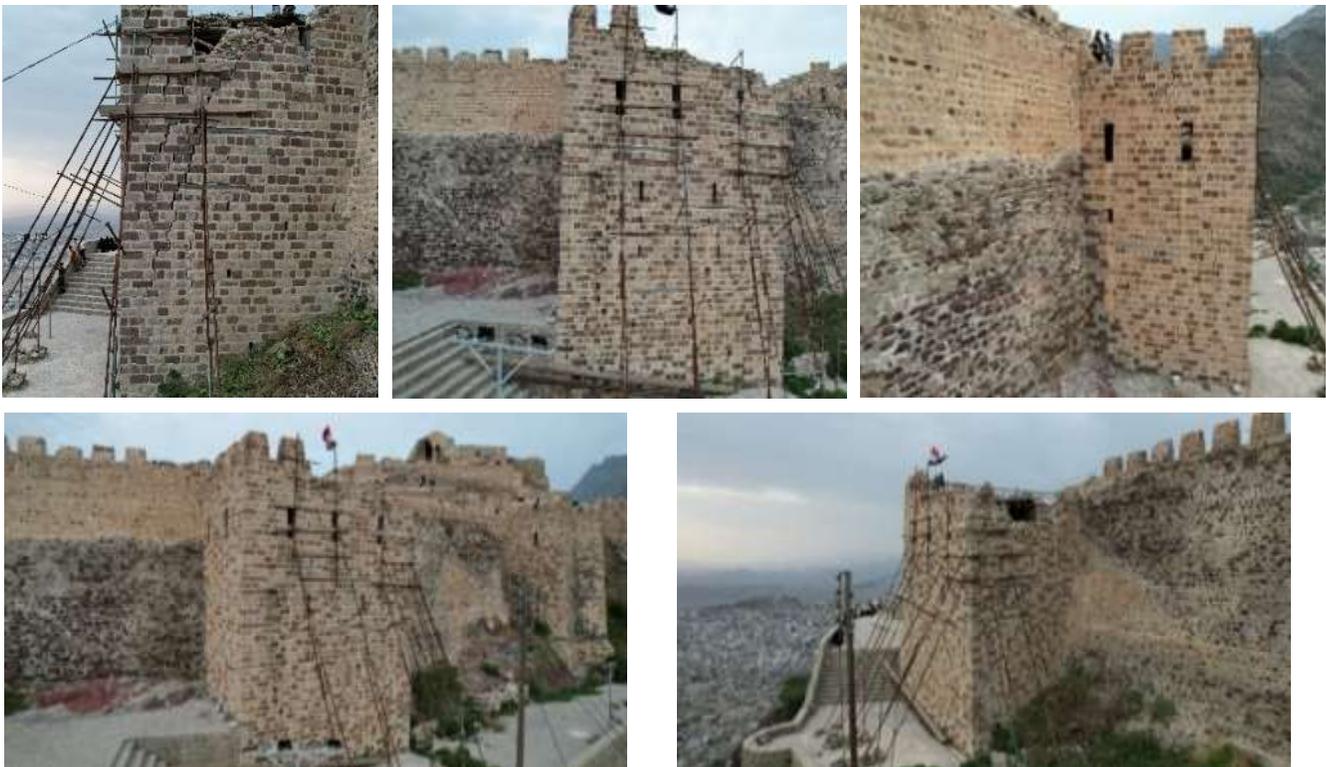
A three-dimensional model of the tower was created using photogrammetry techniques through processing a set of aerial images captured by a drone. The model was generated based on 120 digital images, as shown in Figure (6); were used to generate an accurate three-dimensional model using Agisoft Metashape software.

Figure 6: The images, taken by drone, 2025.

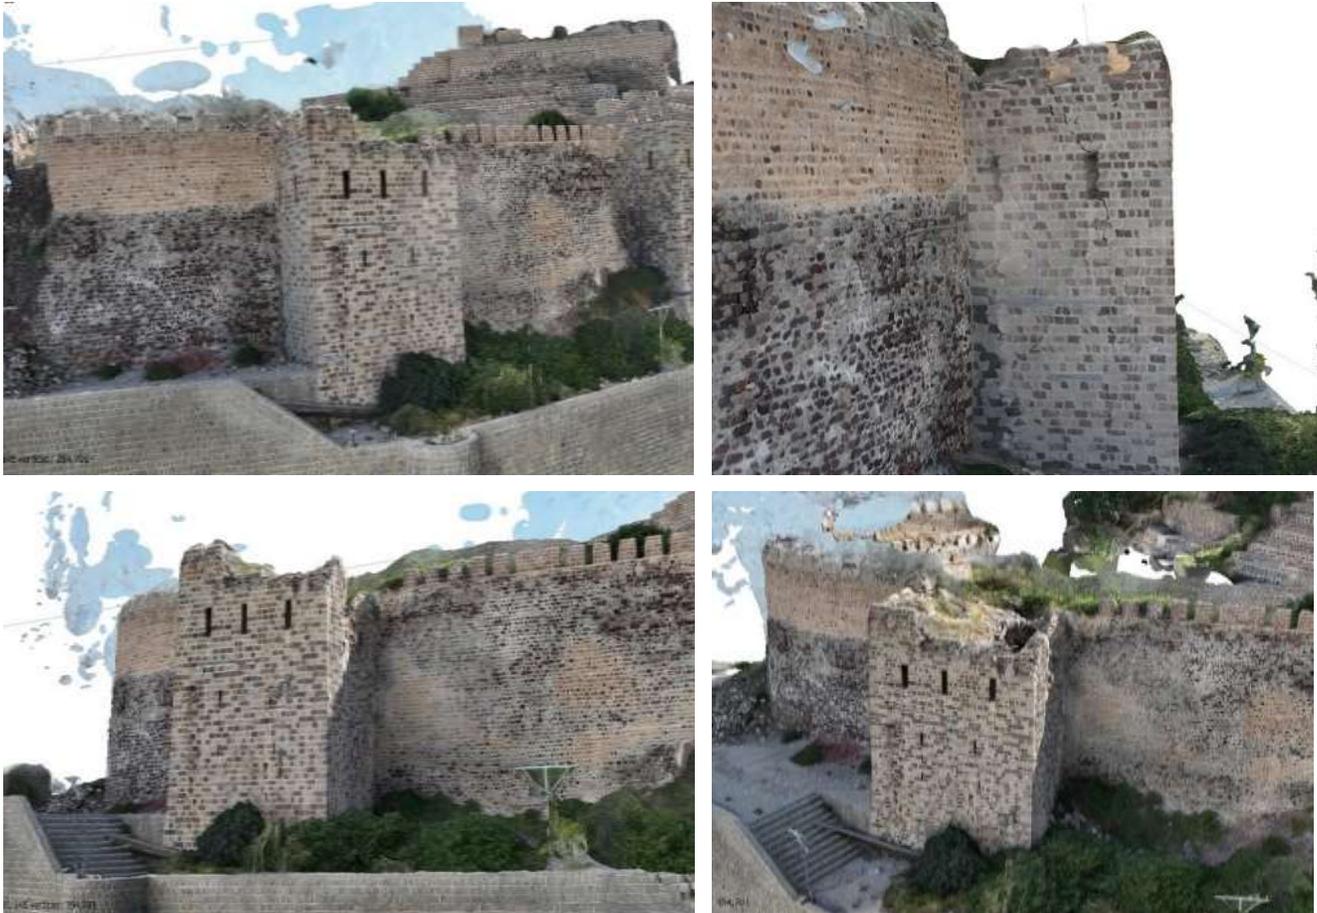
The workflow was implemented in four stages: image alignment, dense point cloud generation, mesh construction, and texturing. These stages resulted in forming a clear three-dimensional model as shown in Figure (7), contributing to facilitating the structural and technical analysis process and assessing the structural condition with high accuracy. This enabled precise documentation of the tower's current condition, analysis of damages and structural defects, monitoring of stone material deterioration manifestations, identification of stone erosion locations, and support for the technical assessment of risk levels and structural stability.

Figure 7 : shows the three-dimensional model of the western tower using Agisoft Metashape software.

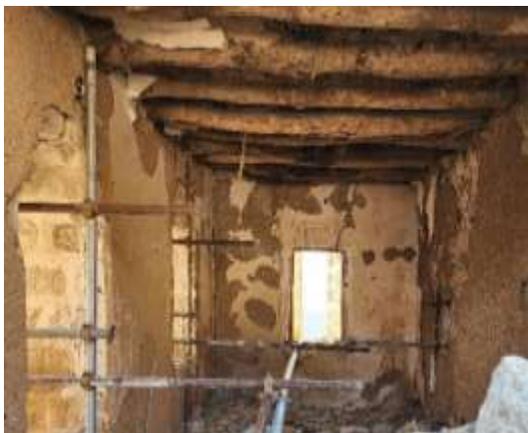
Figure 12: Shows the damage to the internal walls of the tower,2025

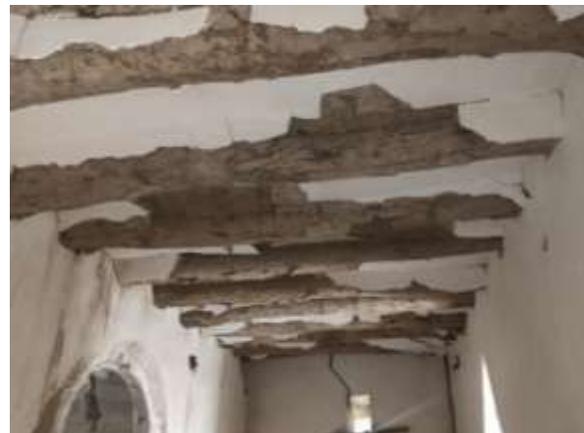
Figure 13: Shows the damage to the internal ceiling of the tower,2025

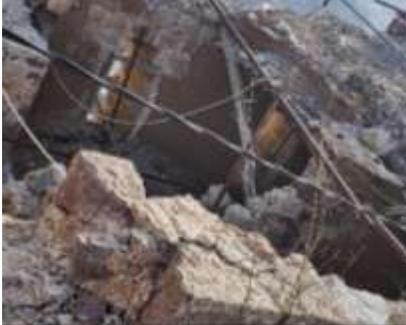
Mechanical erosion (due to direct bombardment)	8/10	Stones are shattered and crumbled by direct bombardment

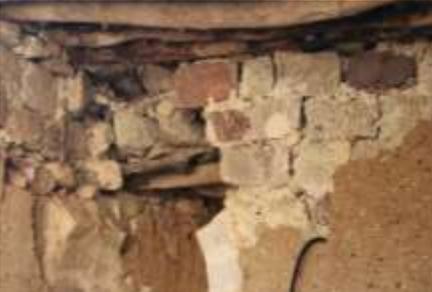
Chemical erosion (due to moisture and salts)	7/10	Surface disintegration and erosion of stones due to their continuous exposure to moisture and salts

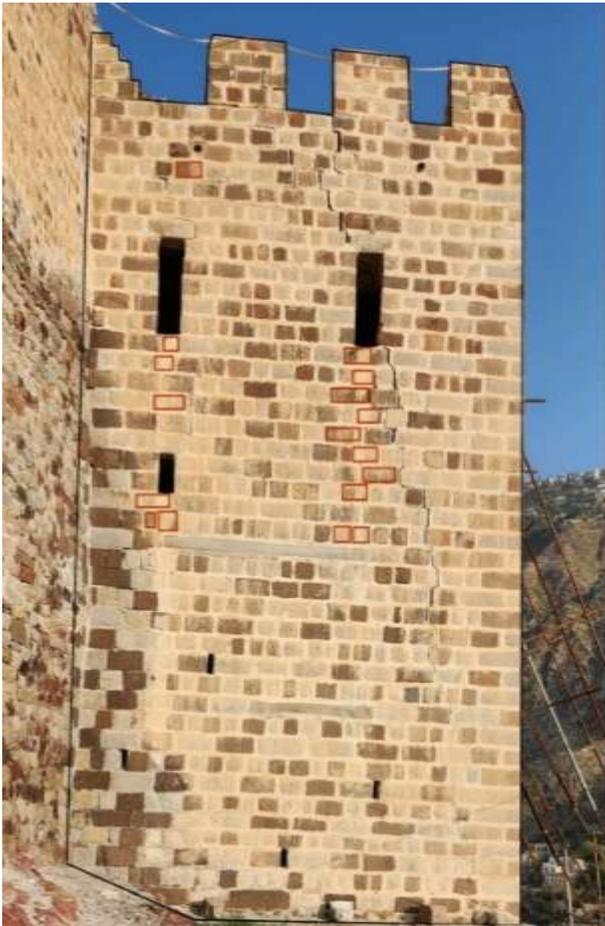
Figure 14: The photo shows stones marked in red for moisture paths on the northern façade.

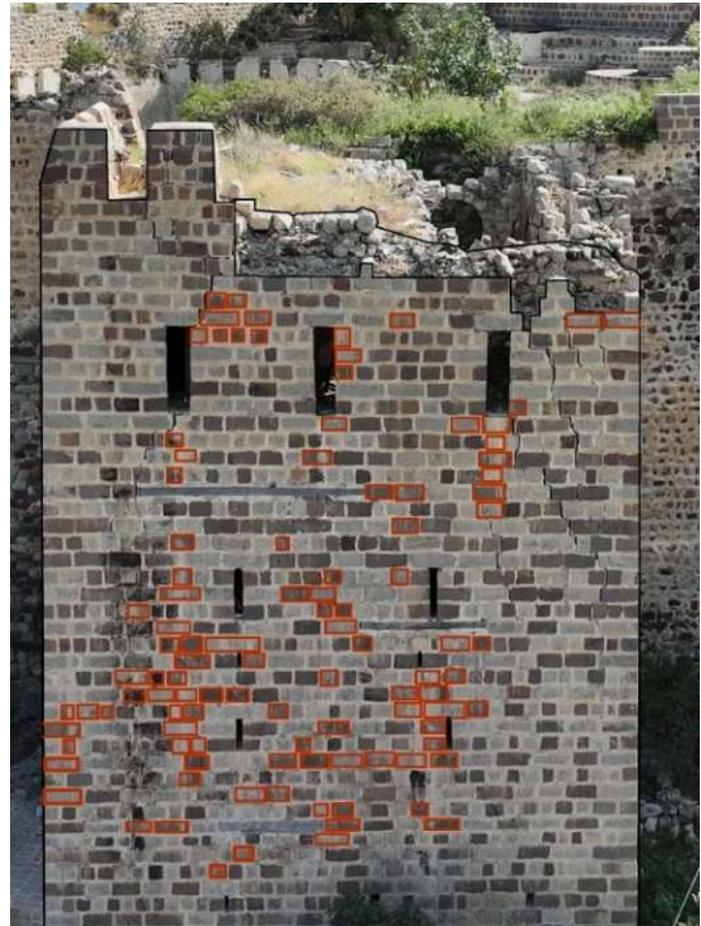
Figure 15: The photo shows stones marked in red for moisture paths on the western façade.

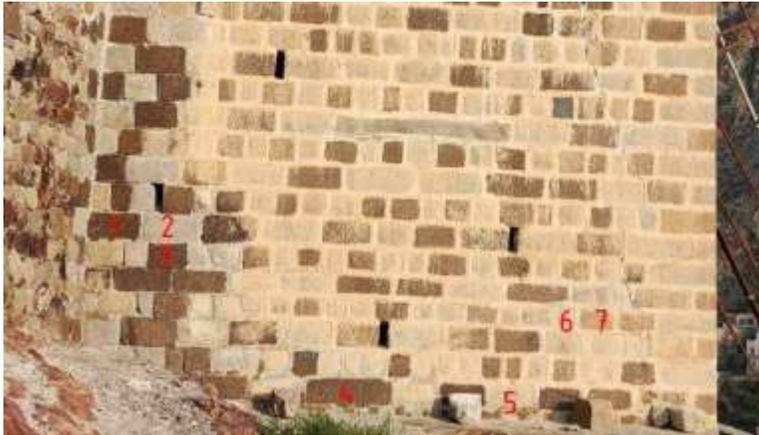
The measurements on the northern facade showed high moisture values recorded at most inspection points, with the highest reading of (52) in limestone, followed by other high readings in limestone stones at (45 and 45.5), values indicating very high moisture according to the adopted standards. A reading of (35) was also recorded in one location of granite stone, indicating its exposure to high moisture as well. In contrast, readings of some granite stones ranged between (12.8 – 16.6), within the medium moisture range, while limestone recorded a reading of (13.4) indicating medium moisture. These results reflect the higher capacity of limestone stones to absorb moisture compared to granite stones. Additionally, the northern facade's limited exposure to sunlight limits natural drying processes, leading to moisture retention within the stone for long periods, which increases the likelihood of deterioration in the mechanical properties of the stones.

Number	Stone type	Humidity level
1	limestone	52
2	Granite stone	35
3	limestone	45
4	limestone	45.5
5	Granite stone	12.8
6	Granite stone	16.6
7	limestone	13.4

Figure 16: the Protimeter moisture meter of the northern facade

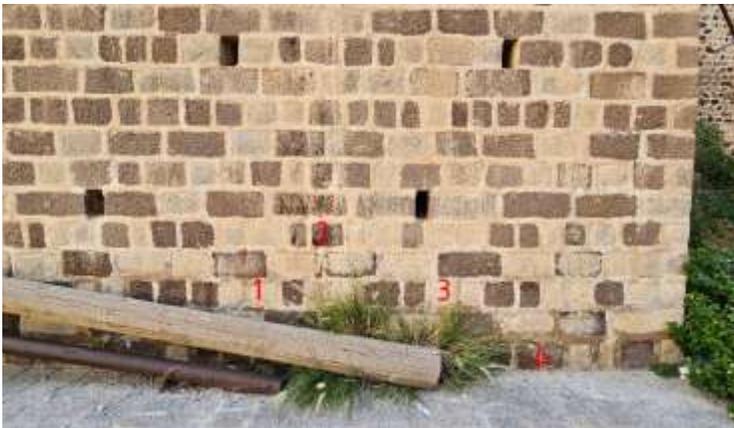
Number	Stone type	Humidity level
1	Granite stone	21.7
2	limestone	24.6
3	Granite stone	12.8
4	limestone	25.4

Figure 17: the Protimeter moisture meter of the western facade

Results of measurements on the western facade showed variation in moisture levels between stone types, where limestone recorded high readings of (24.6 and 25.4), values indicating high moisture. Meanwhile, granite stones showed varying readings ranging between (12.8 – 21.7), indicating medium to high moisture. This variation is attributed to the western facade's exposure to frequent climatic changes, leading to expansion and contraction of the stones.

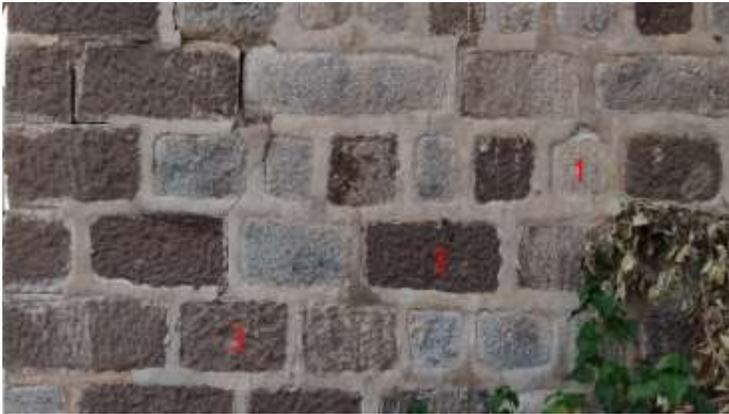
Number	Stone type	Humidity level
1	Granite stone	12
2	limestone	27
3	limestone	31

Figure 18: the Protimeter moisture meter of the western facade

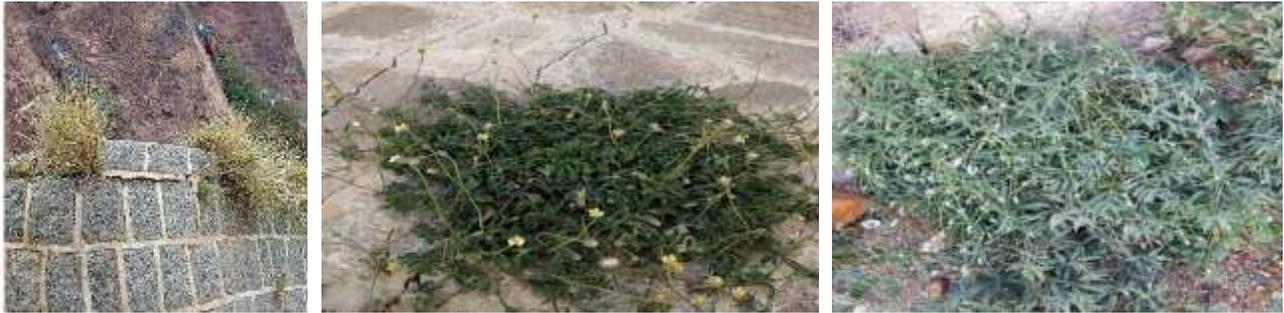
Figure 1: Pictures Shows a group of herbaceous plants. Source: Researcher. Location: Al-Qahira Citadel, Taiz, 2025

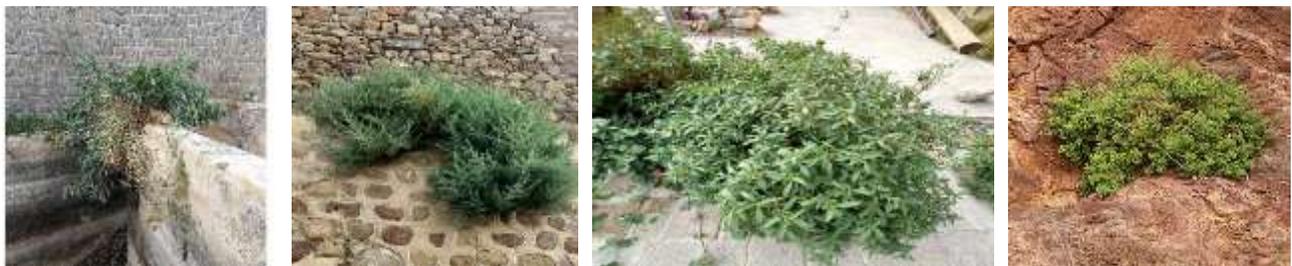
Figure 2: Pictures Shows a group of shrubby plants. Source: Researcher. Location: Al-Qahira Citadel, Taiz, 2025

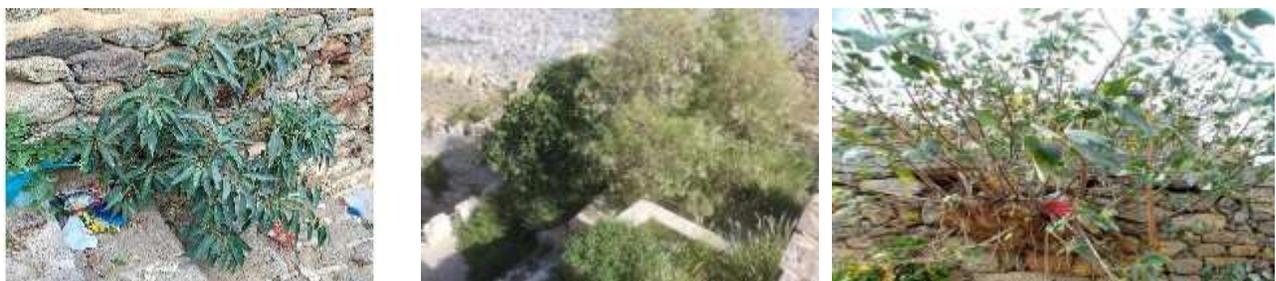
Figure 3: Pictures Shows a group of tree plants. Source: Researcher. Location: Al-Qahira Citadel, Taiz, 2025

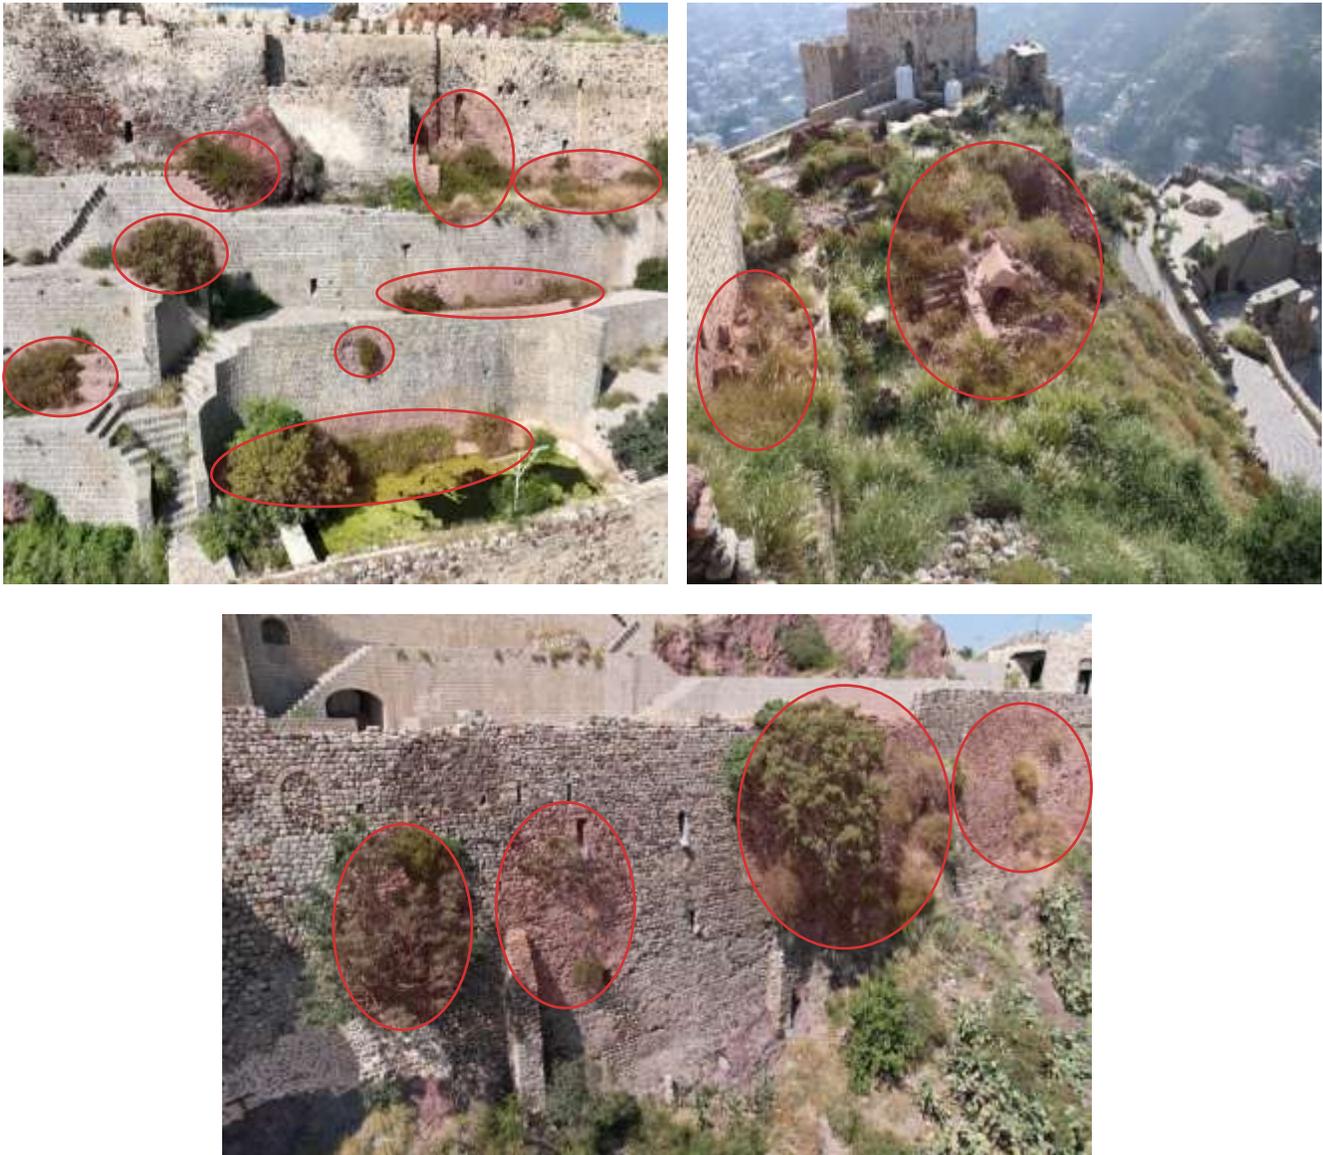
Figure 4: Pictures showing Drone-based aerial imagery reveals the concentration of vegetation within cracks, stone joints, and moisture-prone areas, posing a risk to the structural integrity of architectural elements.

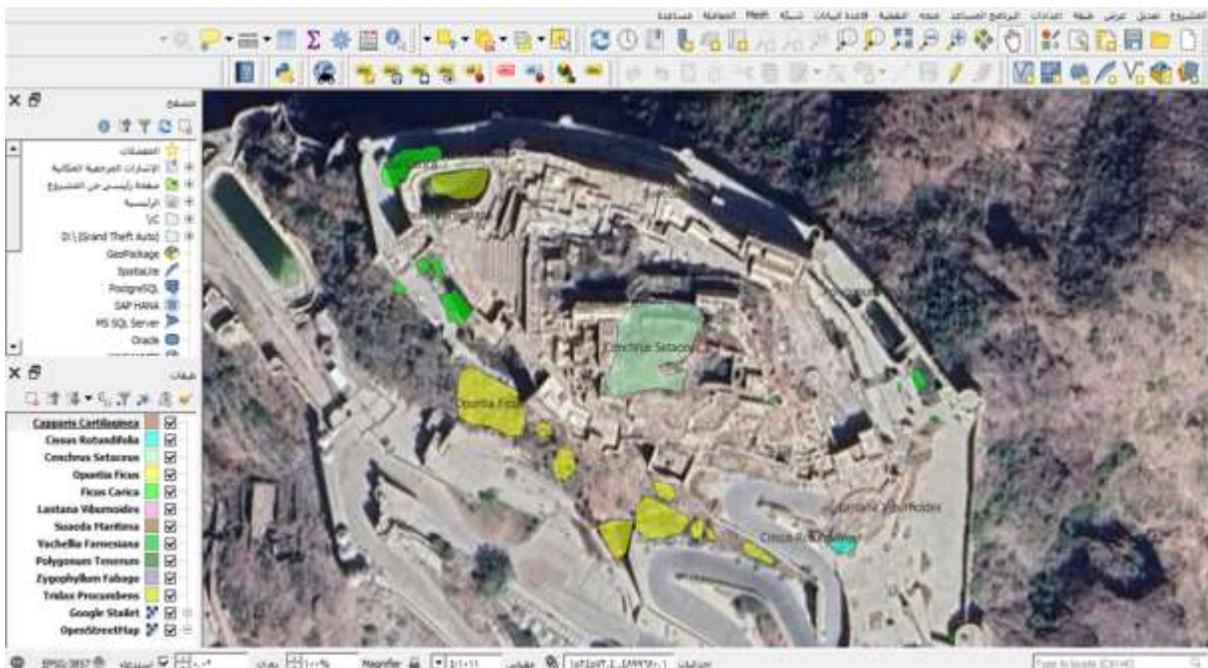
Leveraging ground and aerial images, Geographic Information Systems (GIS) were used to analyze spatial data, where digital maps were prepared illustrating the spatial distribution of vegetation cover within Al-Qahira Citadel, classified by type, density, and hazard level. This was achieved by creating independent spatial layers representing observed plant locations, with each layer linked to a descriptive database (Attribute Table) containing the plant name, scientific name, plant type, structural hazard level, and visual documentation material represented by field and aerial photographs.

Figure 5: GIS map showing the distribution of vegetation cover within Al-Qahira Citadel

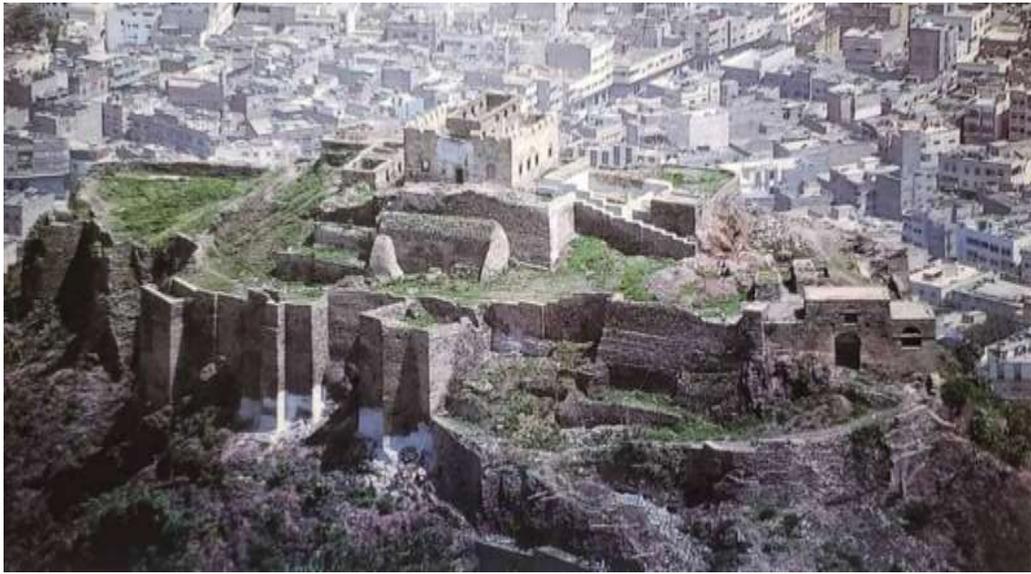
The climate change analysis was supported by conducting a temporal analysis of photographic images documented for Al-Qahira Citadel across different time periods, due to the importance of this type of documentation in tracking the development of vegetation cover and observing its dynamics within the site. Photographs taken in 2004 showed noticeable spread of vegetation cover in several parts of the citadel, reflecting the influence of prevailing environmental and climatic factors at that time in promoting plant growth, especially in architectural areas exposed to moisture accumulation.

Figure 7: A picture showing of the Al-Qahira Citadel in 2004.

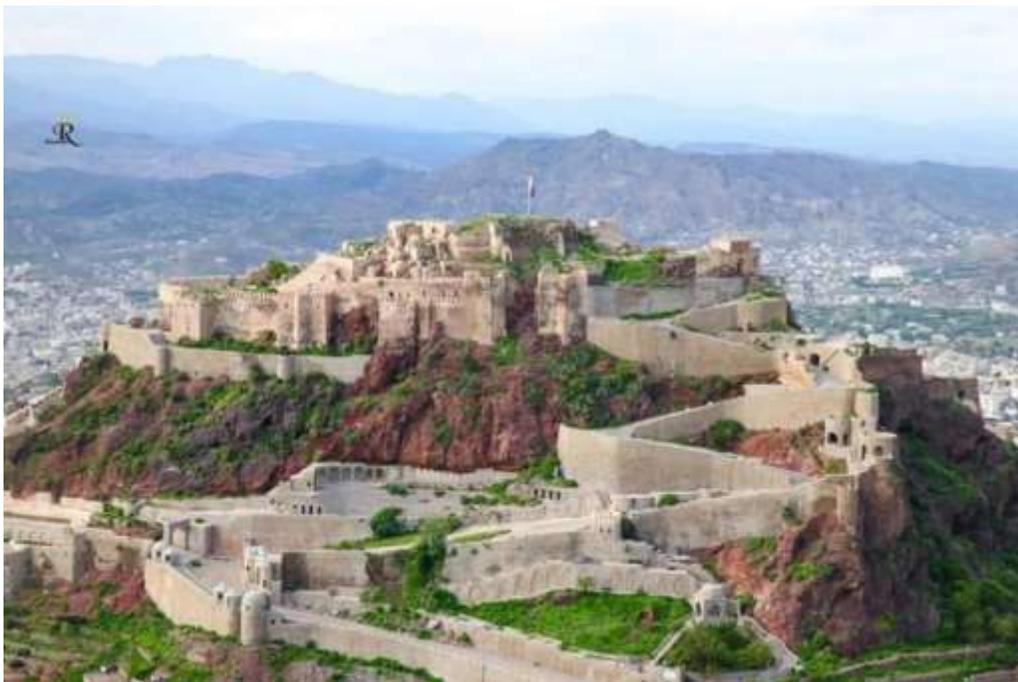
Photographs taken in 2023 revealed near-complete dominance of vegetation cover over most parts of the citadel, with a clear increase in its density and spatial extent. This scene aligns with the results of climatic data analysis, which showed rising seasonal humidity levels and frequent rainfall periods, alongside the absence of routine maintenance works during that phase, contributing to the exacerbation of invasive vegetation cover within the architectural fabric of the citadel.

Figure 8: A picture showing of the Al-Qahira Citadel in 2023.

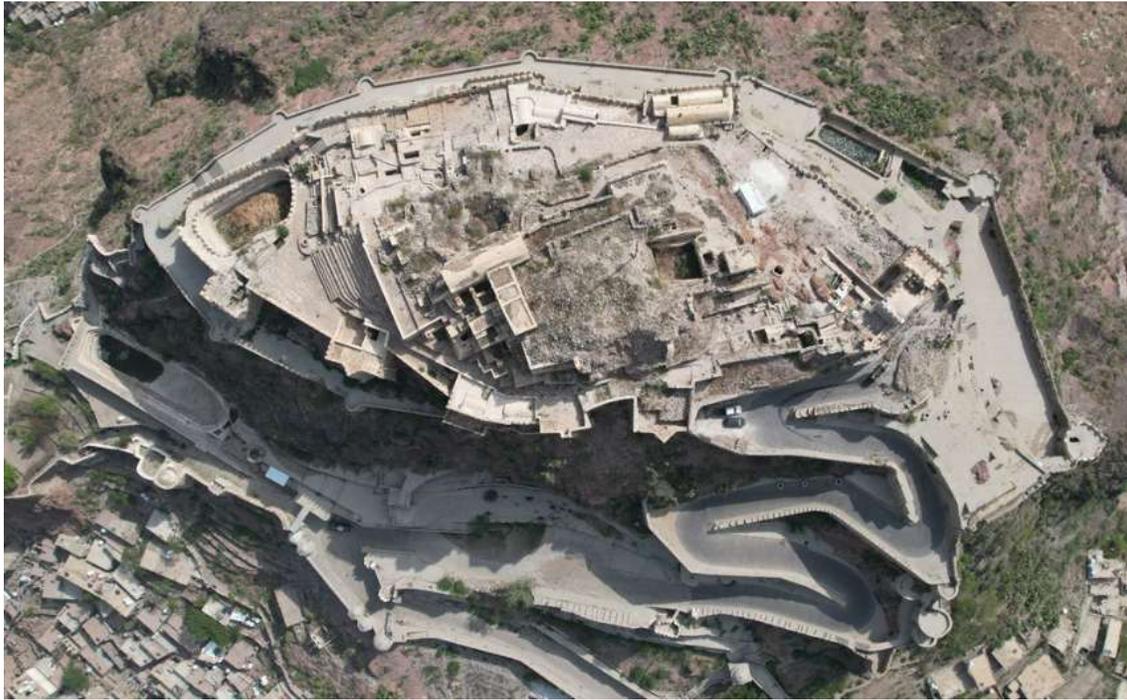
In contrast, photographs taken in 2025 showed a clear decline in vegetation cover spread, with the citadel appearing nearly free of plants, resulting from the implementation of vegetation removal works and improved site care. This temporal contrast confirms that vegetation cover spread is not linked to climatic factors alone but is directly influenced by the level of management, maintenance, and human intervention, highlighting the importance of preventive policies in protecting heritage sites.

Figure 9: A picture showing of the Al-Qahira Citadel in 2025

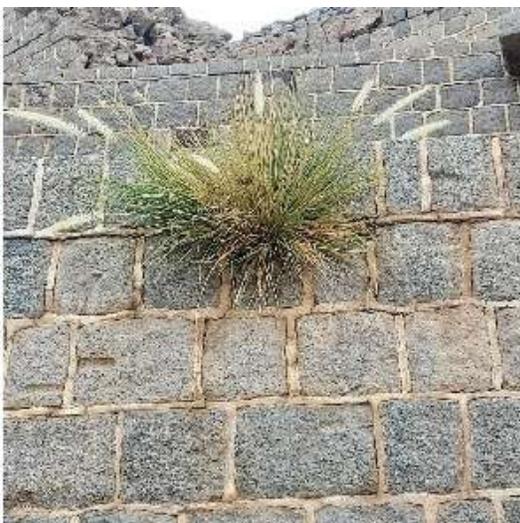
Figure 10: Pictures showing the growth of herbaceous plants within cracks and stone joints in the wall of Al-Qahira Citadel.

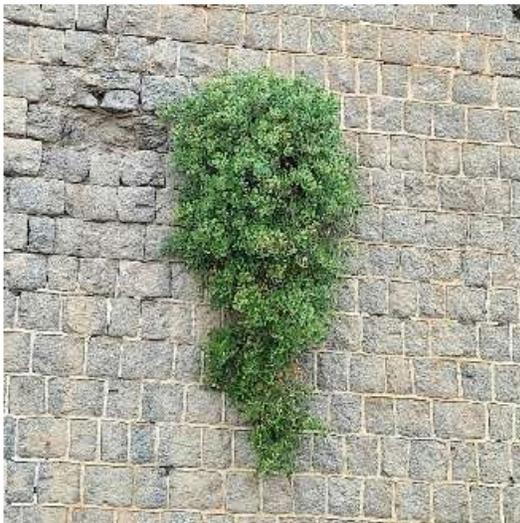
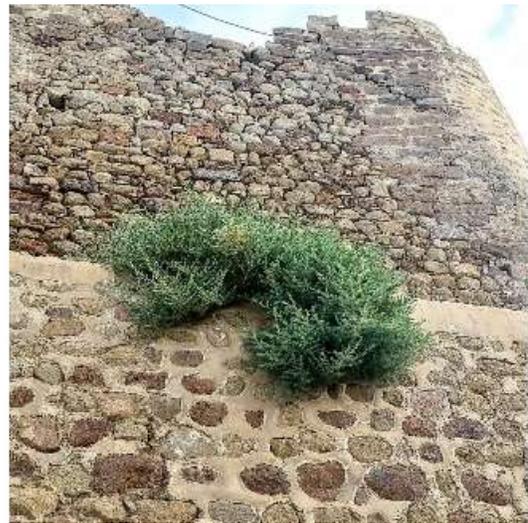
Figure 11: Pictures illustrating a growth site of shrubs on the wall of Al-Qahira Citadel, where plants appear penetrating cracks and stone joints, indicating their potential impact on the cohesion of architectural elements.

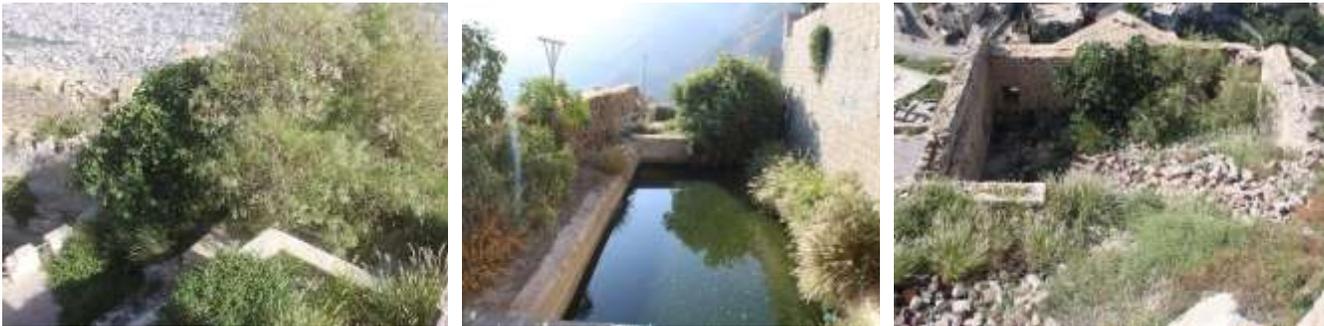
Figure 12: Pictures showing tree growth within Al-Qahira Citadel near architectural elements and foundations.
